Indicative fire test

192007

**Prepared for:**  
**Rutland UK**  
Whittington Way  
Chesterfield  
S41 9AG

### **Indicative Fire Test**

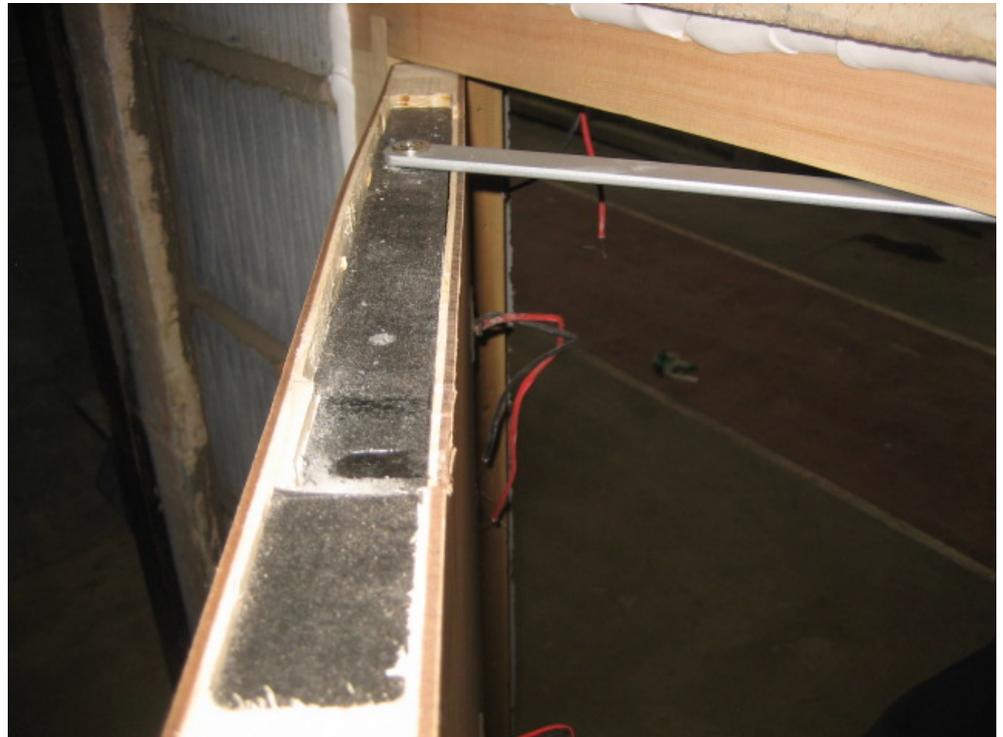
The closer body and intumescent protection at the head of the leaf prior to the start of the test

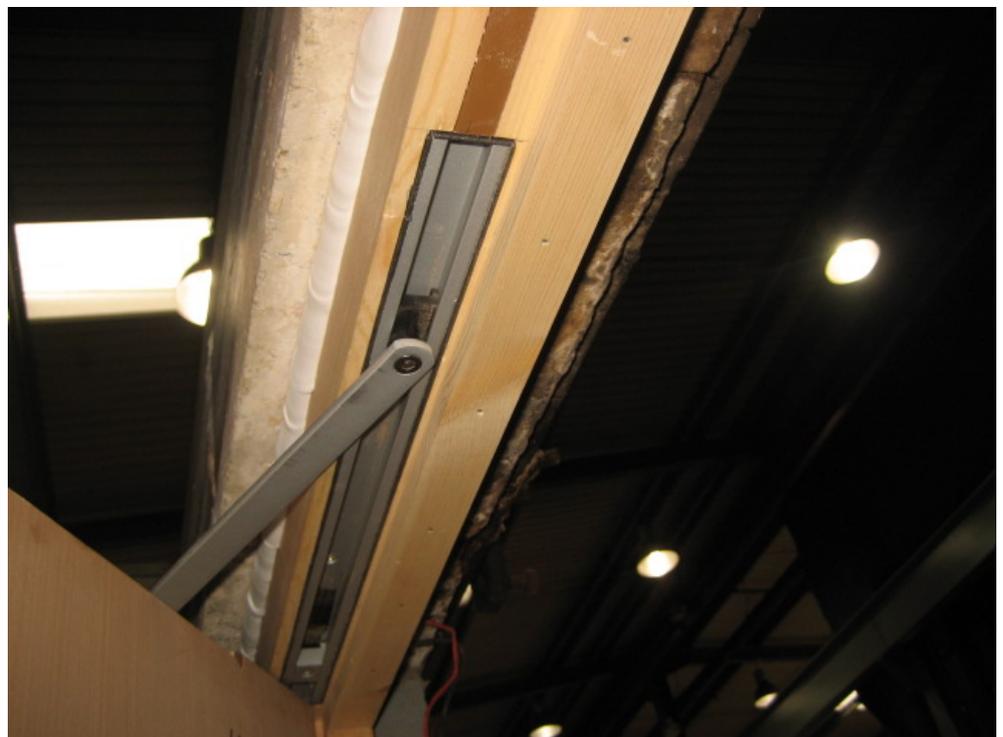
The closer arm rail at the head of the frame prior to the start of the test

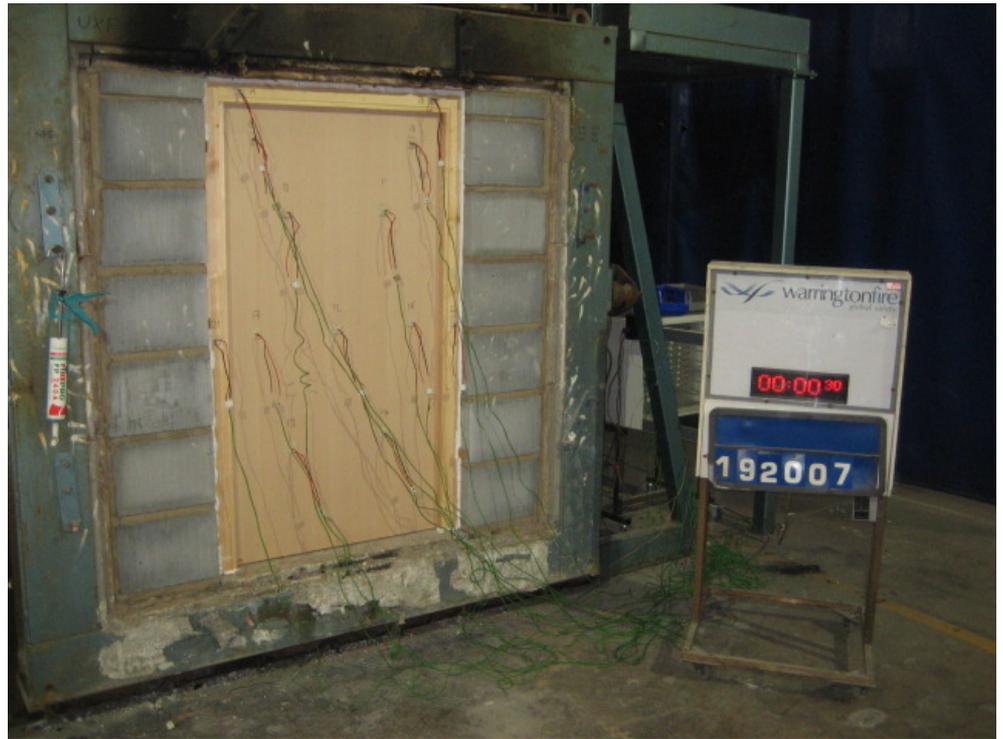
**The unexposed face of the Doorset prior to the start of the test**

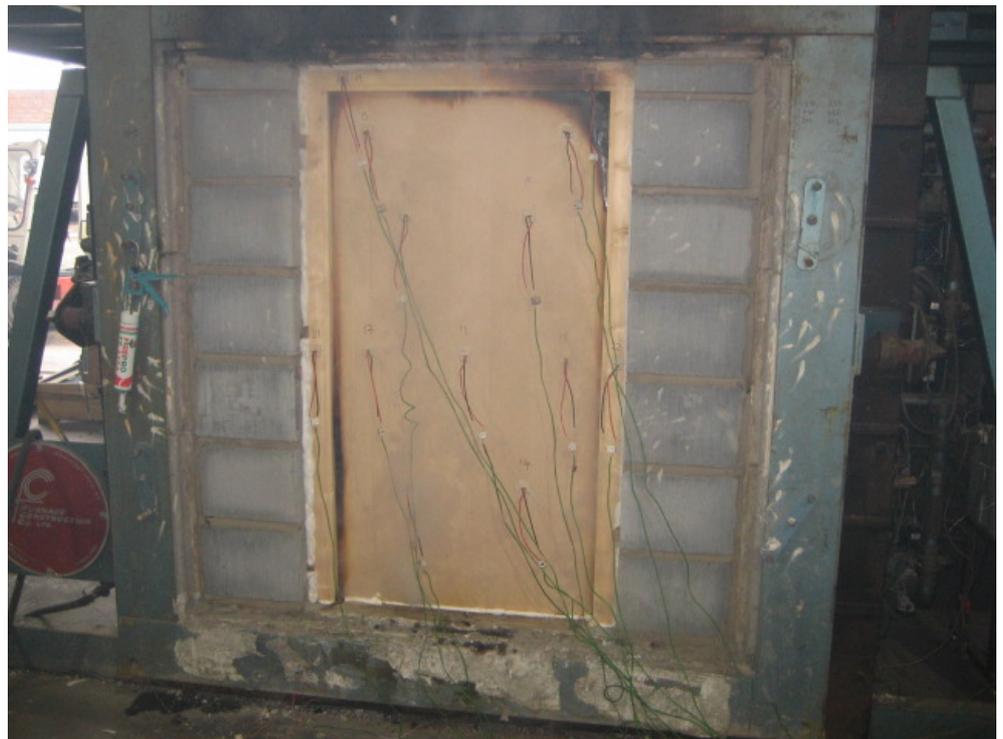
**The unexposed face of the Doorset after a test duration of 15 minutes**

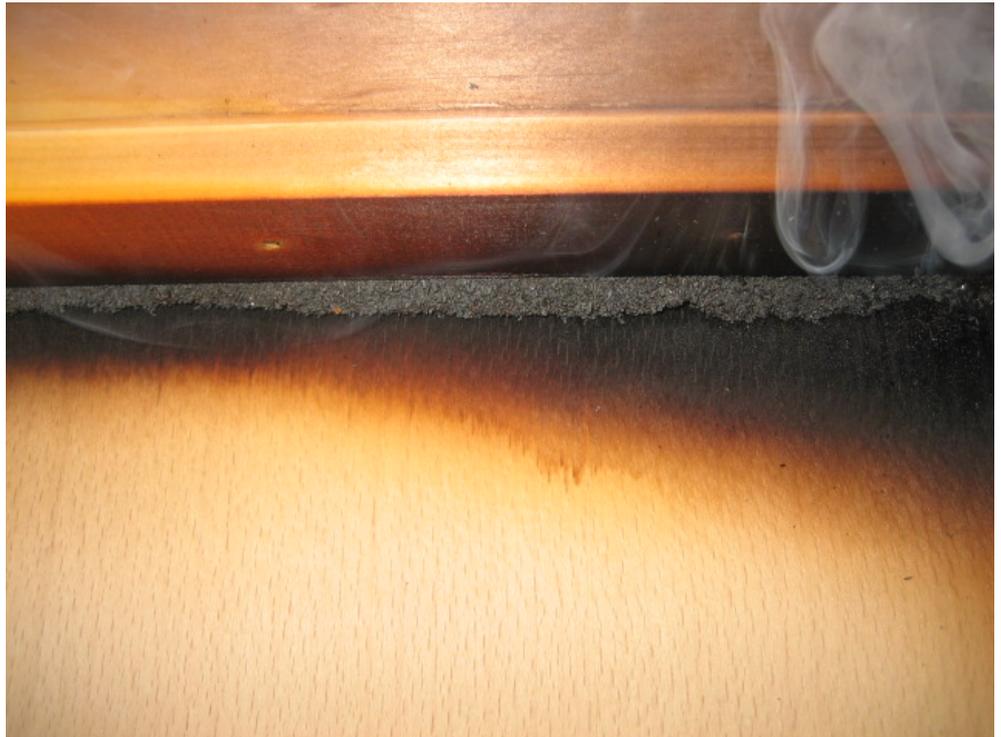
Time		All observations are from the unexposed face unless noted otherwise.
mins	secs	
		The ambient air temperature in the vicinity of the test construction was 16°C at the start of the test with a maximum variation of 1°C during the test.
<b>00</b>	<b>00</b>	<b>The test commences.</b>
<b>02</b>	<b>30</b>	Smoke release commences around the doorset.
<b>05</b>	<b>58</b>	The exposed face of the doorset is blackened; flaming is now visible across the doorset.
<b>08</b>	<b>37</b>	Discolouration is increasing in the top trailing edge corner of the doorset.
<b>15</b>	<b>44</b>	Glowing is visible at the top of jamb on the trailing edge of the doorset,
<b>19</b>	<b>45</b>	The area of glowing at the top of the jamb is sealed off to allow the test to continue, it is not coincidental to the concealed closer.
<b>23</b>	<b>49</b>	Reacted graphite intumescent is visible pushing out between the leaf and frame at the concealed closer position.

<b>28</b>	<b>07</b>	The top and bottom leading edge corners of the door leaf start to bow in towards the furnace.
<b>29</b>	<b>24</b>	Graphite continues to puss out at the head of the doorset around the concealed closer position.
<b>31</b>	<b>55</b>	Smoke release increases at the head of the doorset adjacent to the closer position.
<b>36</b>	<b>22</b>	Discolouration and smoke release continues to increase at the top of the leaf around the closer position, graphite continues to push out.
<b>38</b>	<b>18</b>	The top of the leaf is charred and cracked at the closer position, glowing is now also visible where the leaf is cracked.
<b>40</b>	<b>58</b>	Sustained flaming visible across the head of the doorset starting in the trailing edge corner.
<b>41</b>	<b>00</b>	<b>The test is discontinued.</b>

**Graphite visible at the head of the Doorset adjacent to the closer position approximately 23 minutes into the test**

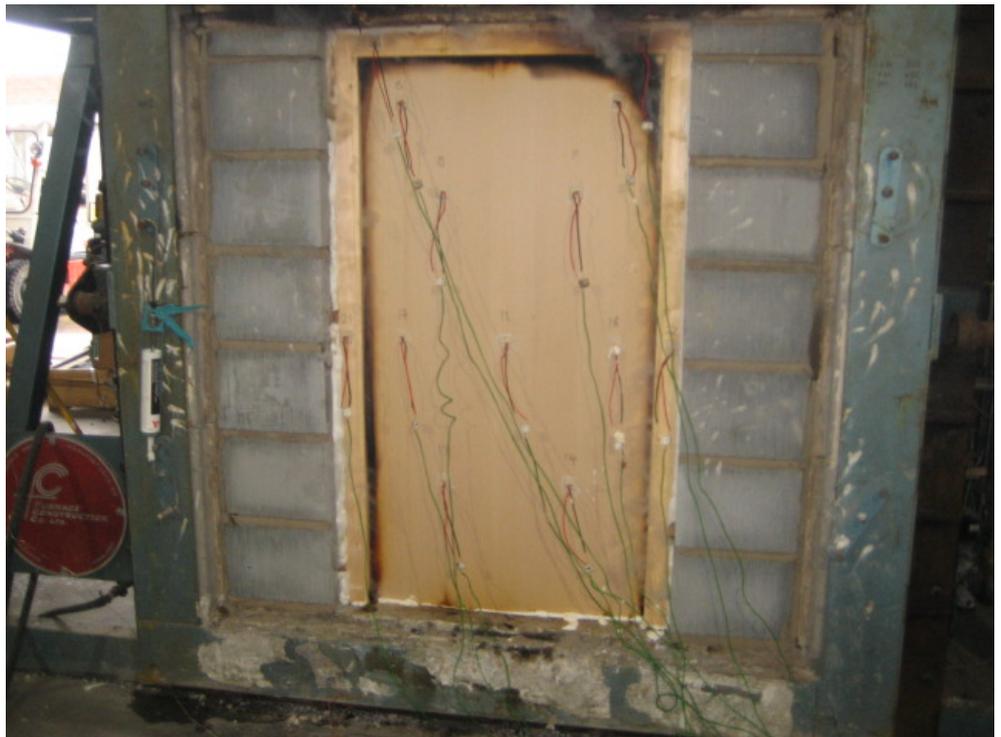
**The unexposed face of the Doorset after a test duration of 30 minutes**

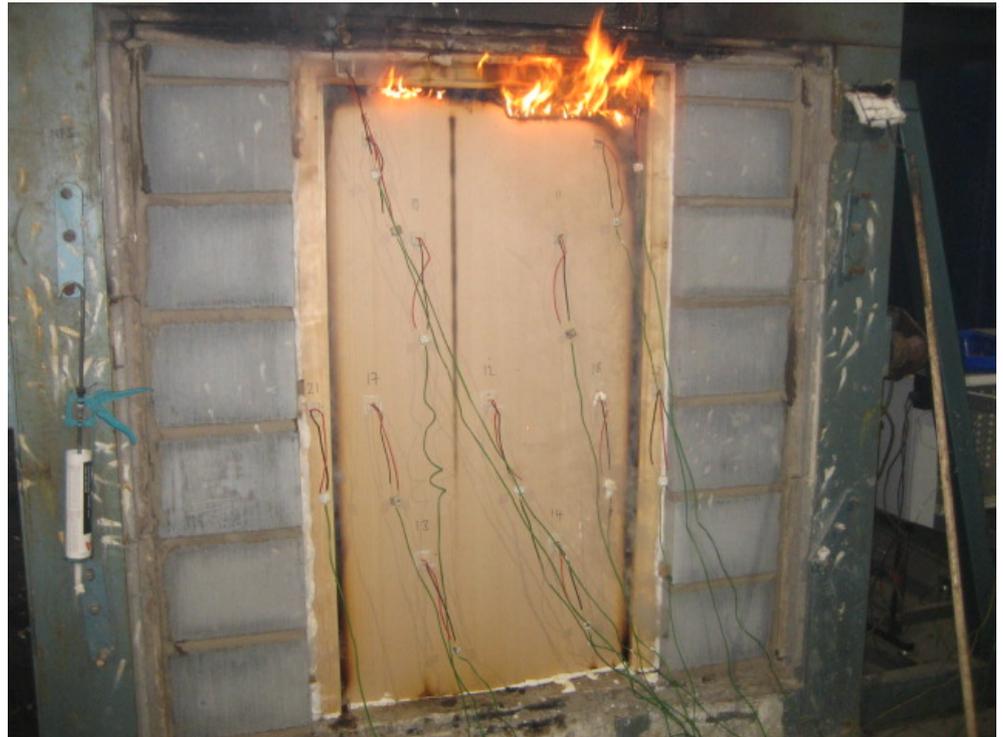
**The unexposed face of the Doorset after a test duration of 40 minutes**

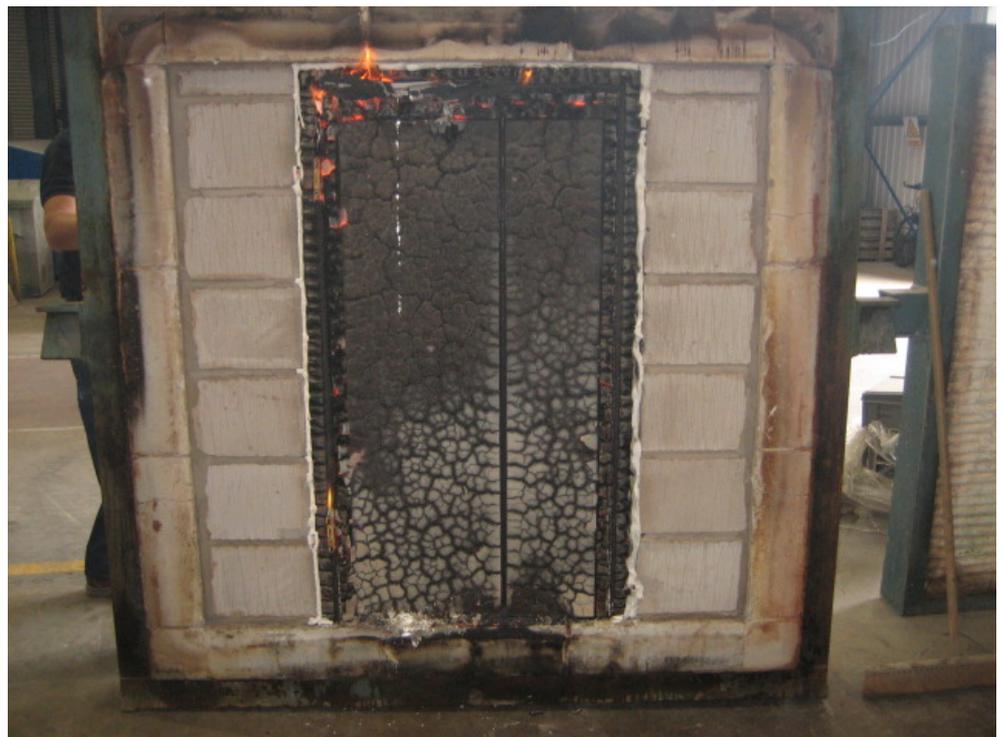
**The exposed face of the Doorset immediately after the test**
