Report Number **BTC 16702F**

A FIRE RESISTANCE TEST, ON TWO SINGLE ACTING SINGLE LEAF DOORSETS, INCORPORATING DOOR CLOSERS BY RUTLAND UK, CONSTRUCTED IN A STANDARD FLEXIBLE SUPPORTING CONSTRUCTION, AND CONDUCTED IN ACCORDANCE WITH BS EN 1634-1: 2008.

Test Date: 8th December 2009

Customer: **Rutland UK**
Whittington Way
Chesterfield
S41 9AG

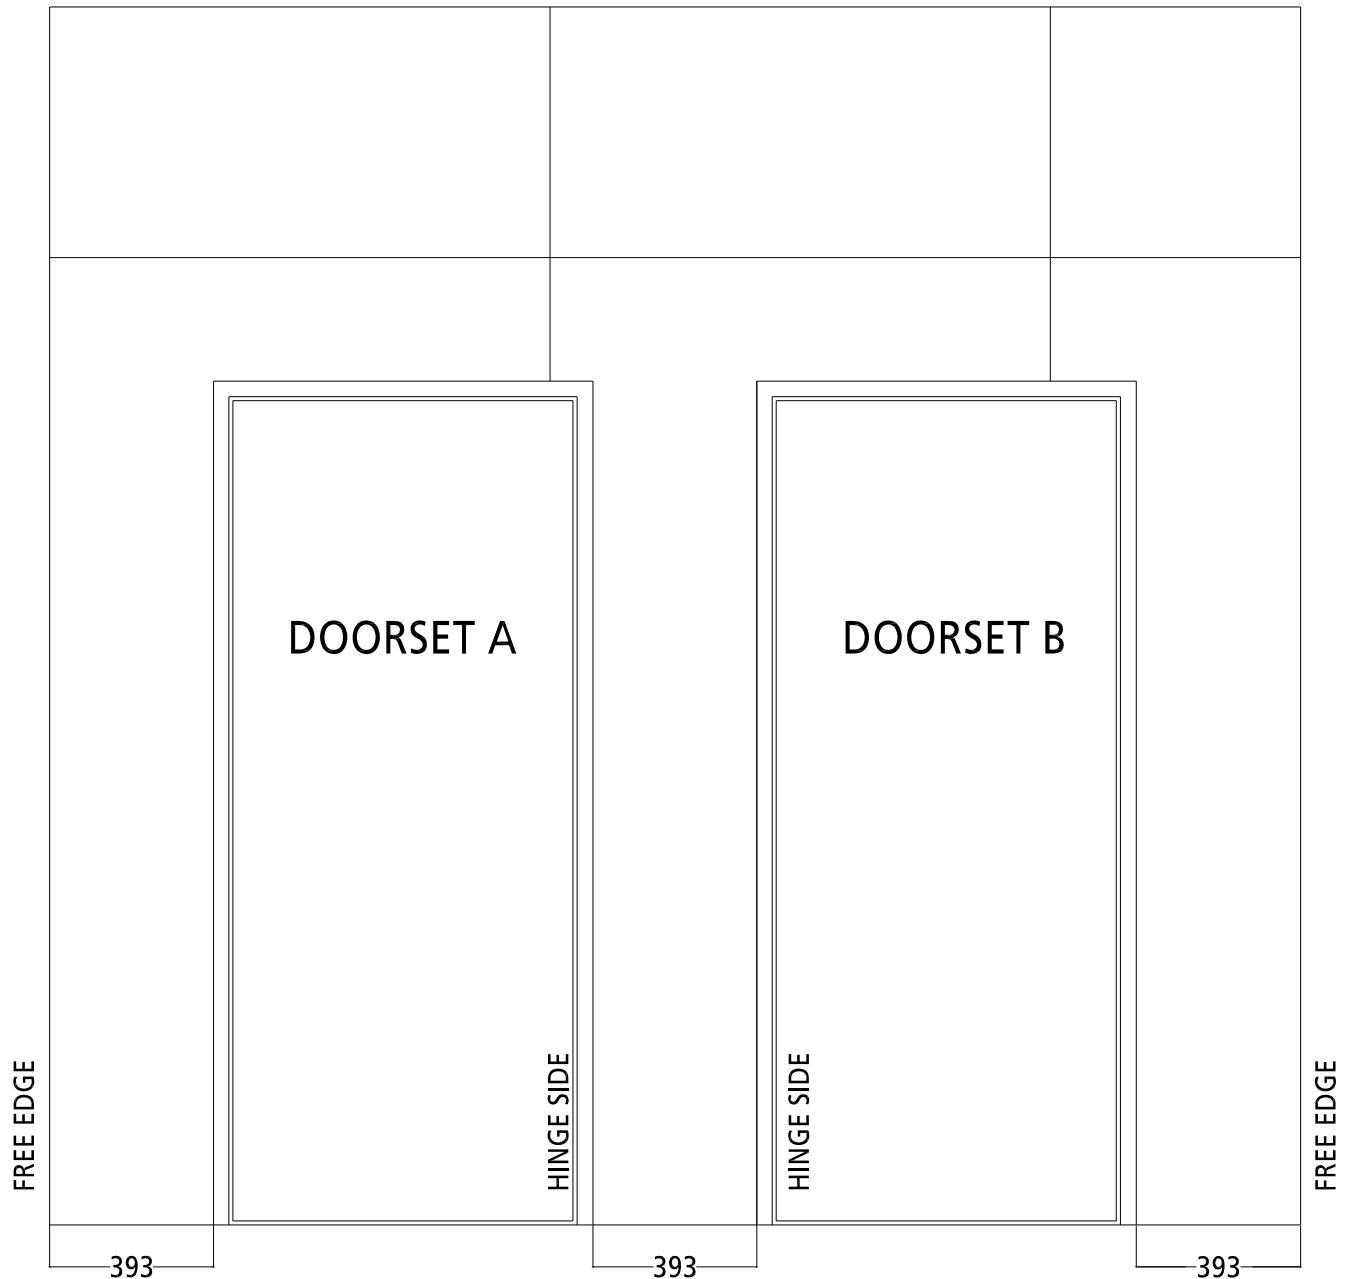
4.5.1 Unexposed face elevation of specimen

Figure 1. Elevation of unexposed face of specimen
Note that dimensions are nominal.

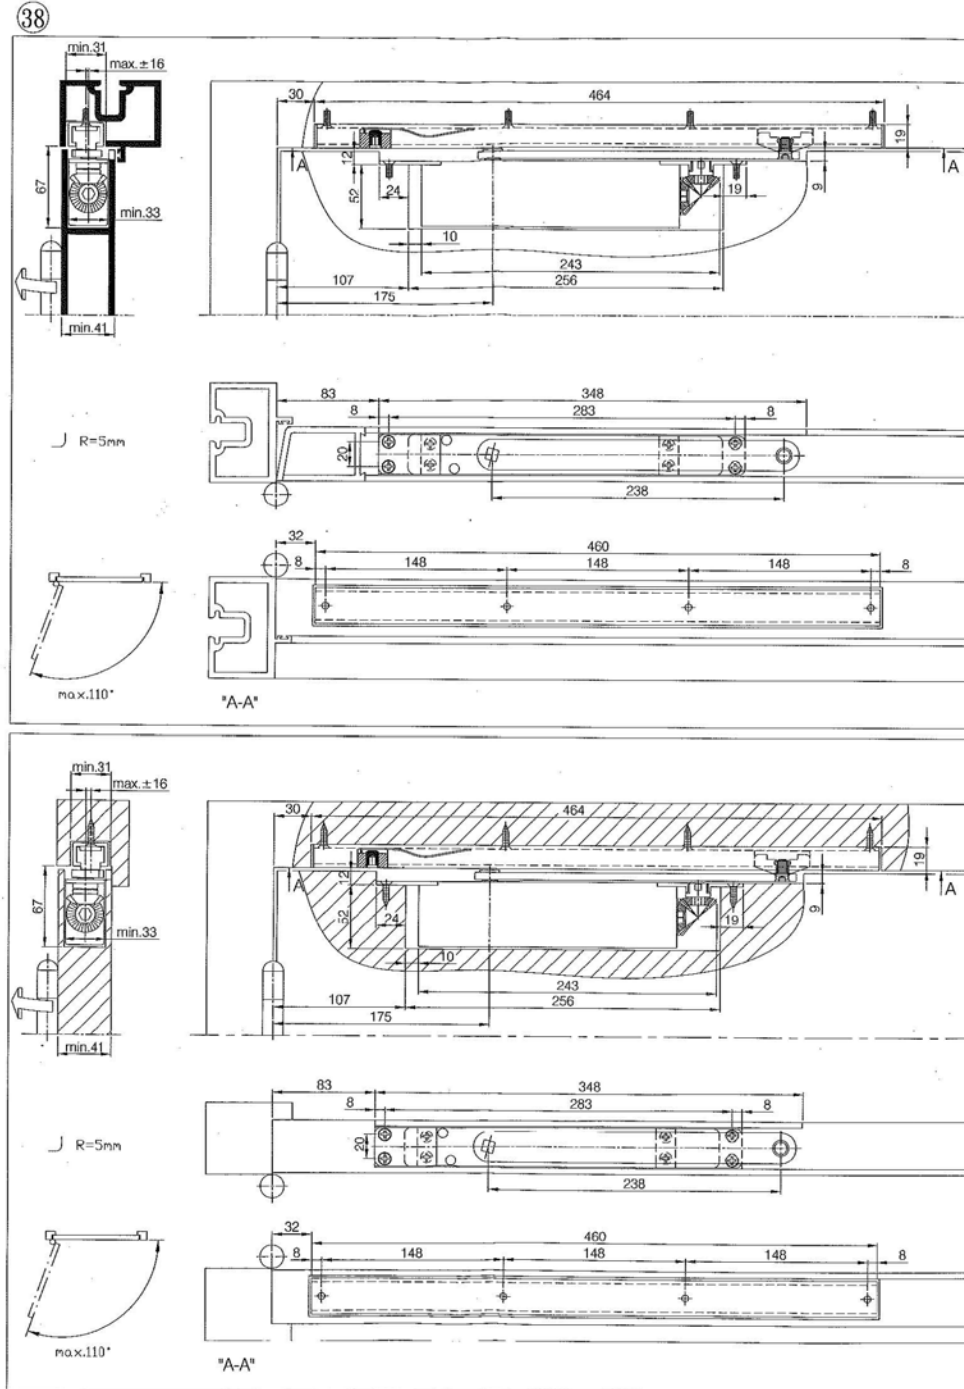
4.5.2 A - Dimensions for ITS 11204 Concealed Door Closer

Figure 2. Door closer dimensions

24	Door closer	
C	Reference	ITS 11204 Concealed Door Closer (factory set at power size 3 to EN 1154). Drawings 4.5.2 and 4.5.3. Photos 9.3, 9.4, and 9.5.
C	Manufacturer	Rutland UK
N/S	Material	N/S
BTC	Overall size	<p><u>Closer:</u></p> <p>Height 53mm</p> <p>Length 210mm (299mm overall)</p> <p>Depth 31mm</p> <p><u>Closer arm concealed rail:</u></p> <p>Length 460mm</p> <p>Width 30mm</p>
C BTC	Fitting	<p>As manufacturer's installation instructions.</p> <p>The door closer was fitted internally in a recess in head of door leaf, centred on the thickness of the door leaf.</p> <p>The door leaf opened into the furnace.</p> <p>The closer arm concealed rail fitted into the head of the door frame and had a 2mm thick Therm-A-Flex intumescent strip around it (on all vertical sides but not at the back of it).</p>
	<u>Intumescent on face plate at head of door leaf</u>	
C BTC	Reference	Therm-A-Flex

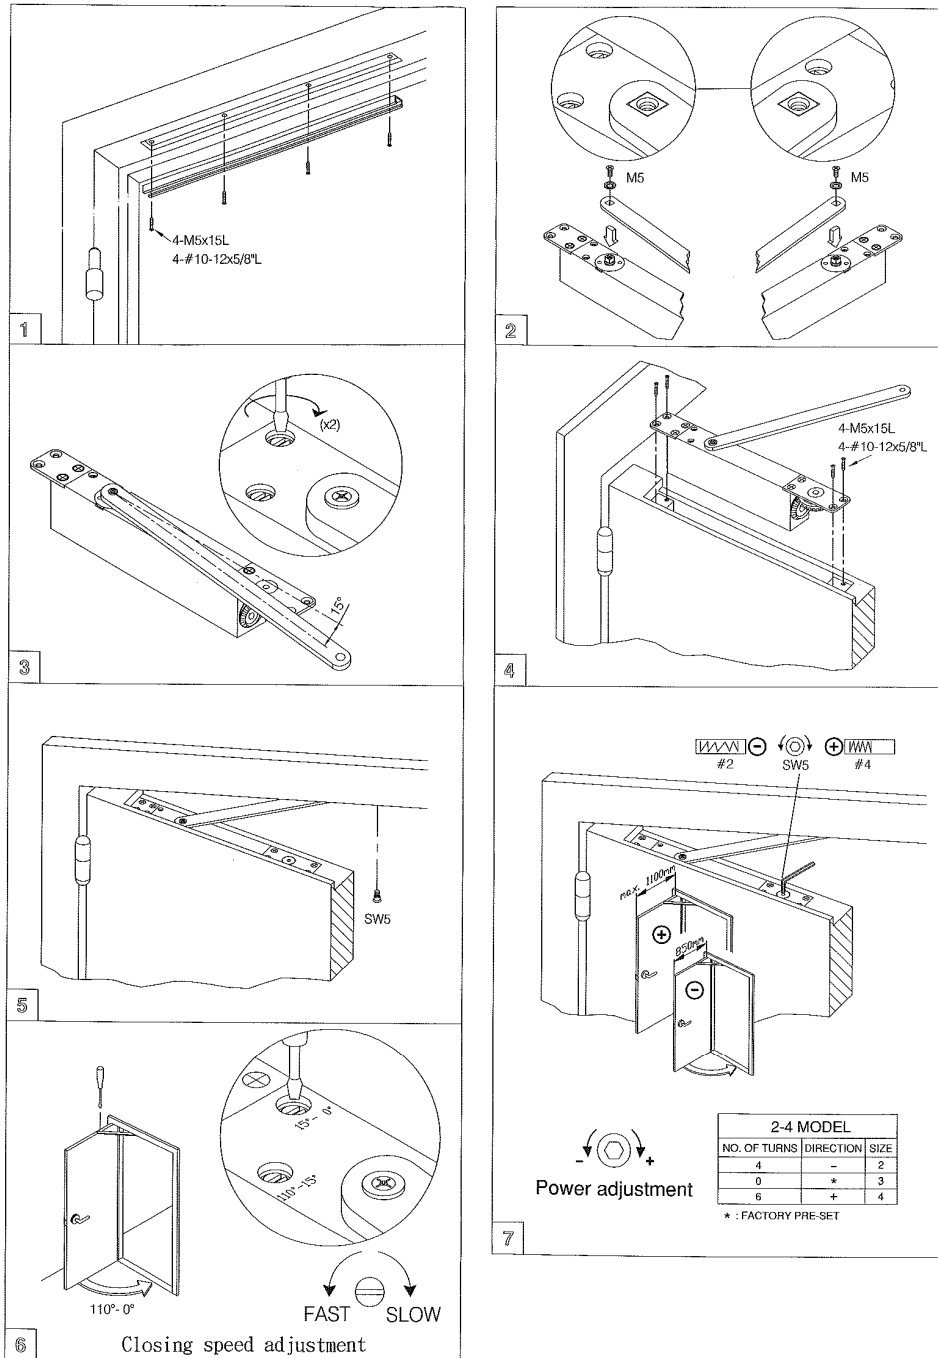
4.5.3 A - Fixing Instructions for ITS 11204 Concealed Door Closer

Figure 3. Fixing Instructions

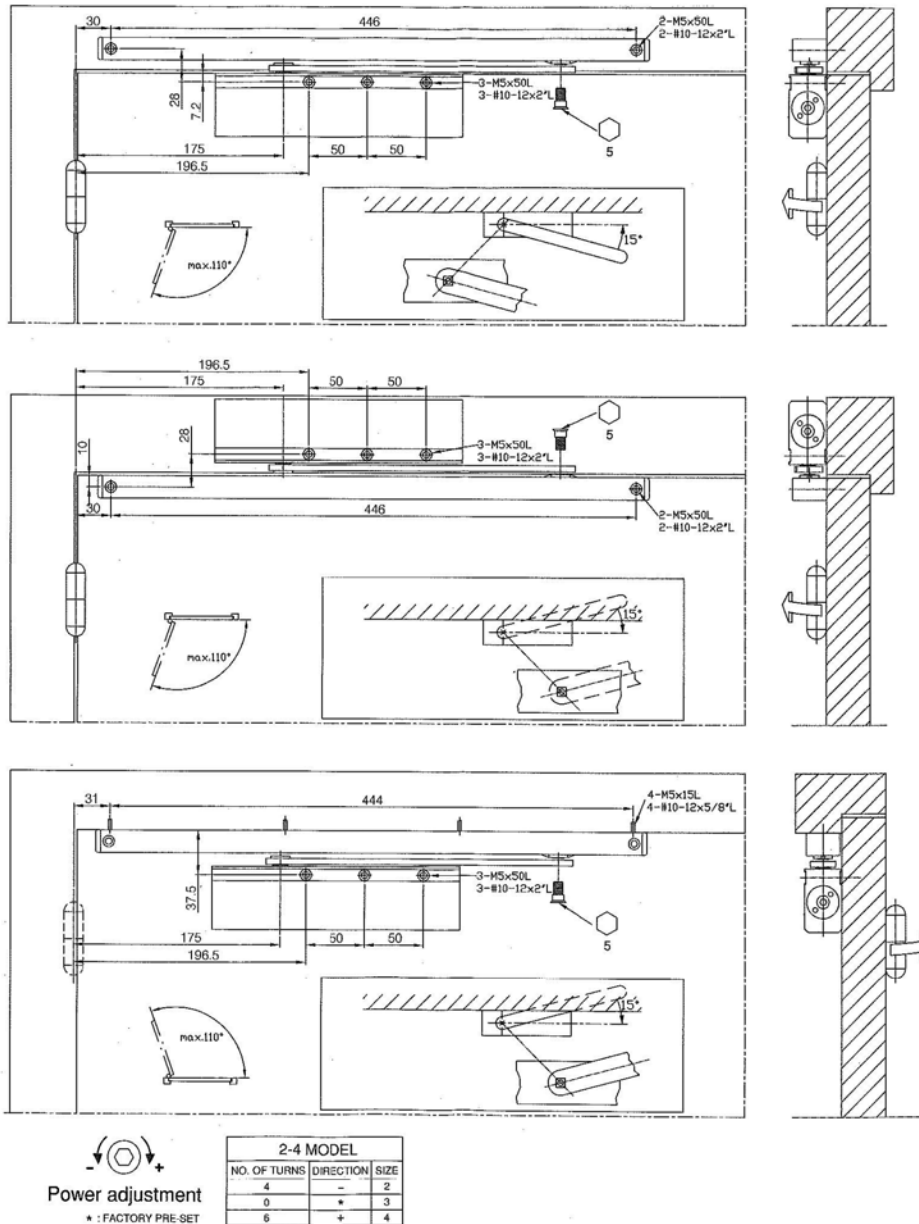
Surface Mounting door closer
 power adjustable #2 - #4

Figure 4. Fixing instructions and dimensions

Doorset B refers to right-hand doorset viewed from the unexposed face.
 See drawing 4.5.4 and photos 9.1, 9.2, and 9.9 to 9.12.

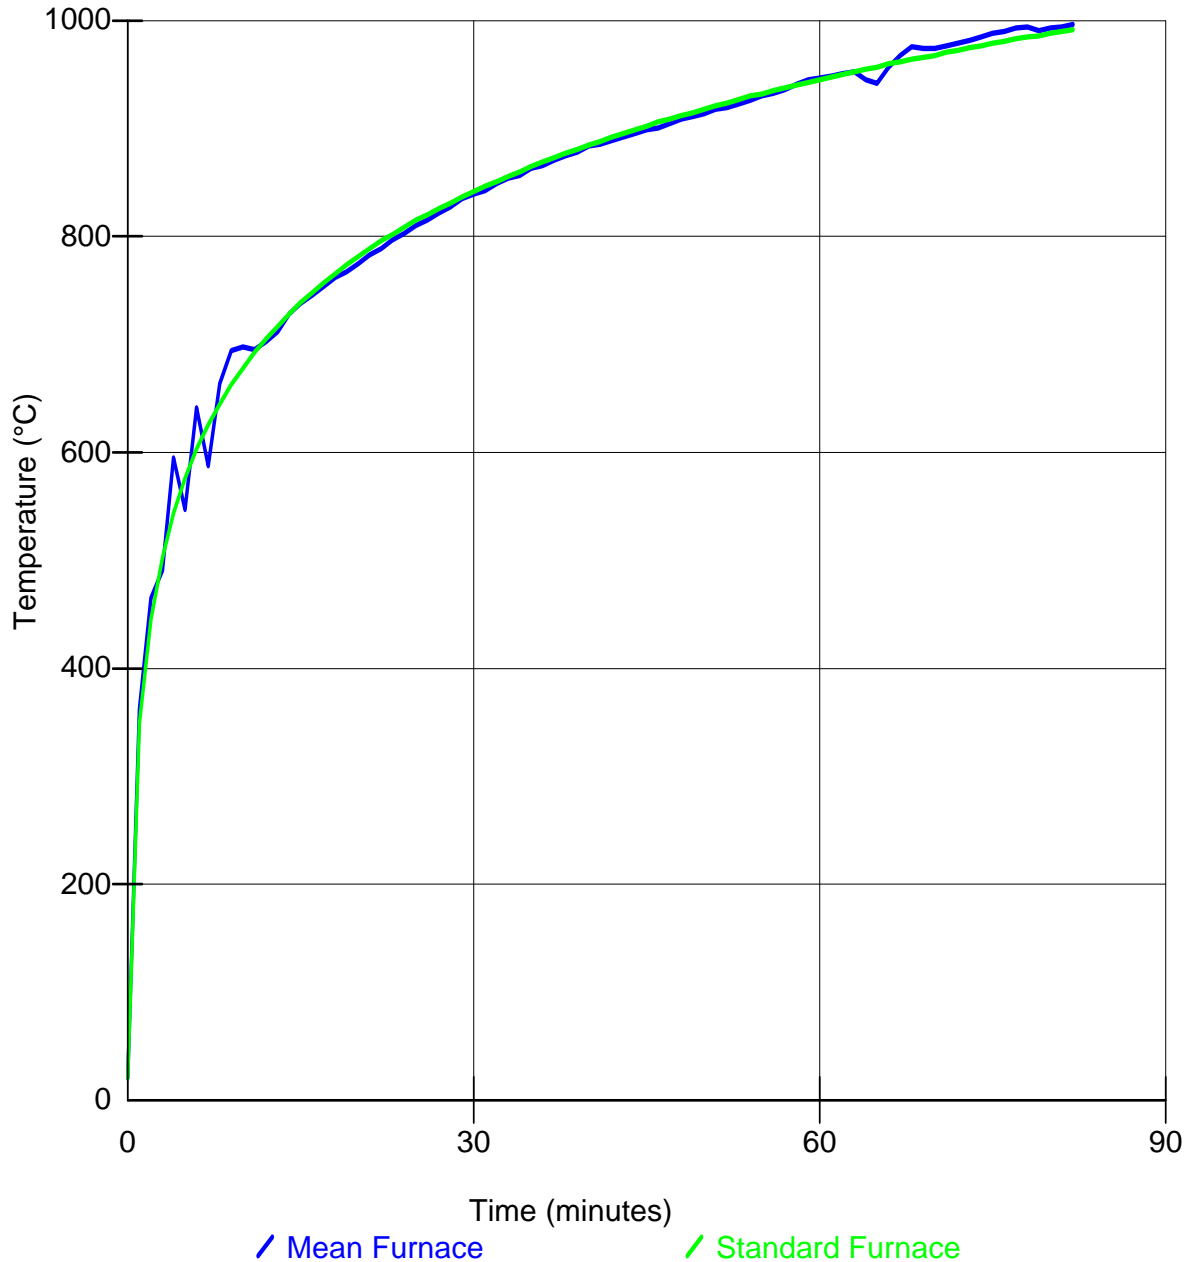
8.3 Furnace Temperature Graph

Figure 5. Furnace temperature graph.

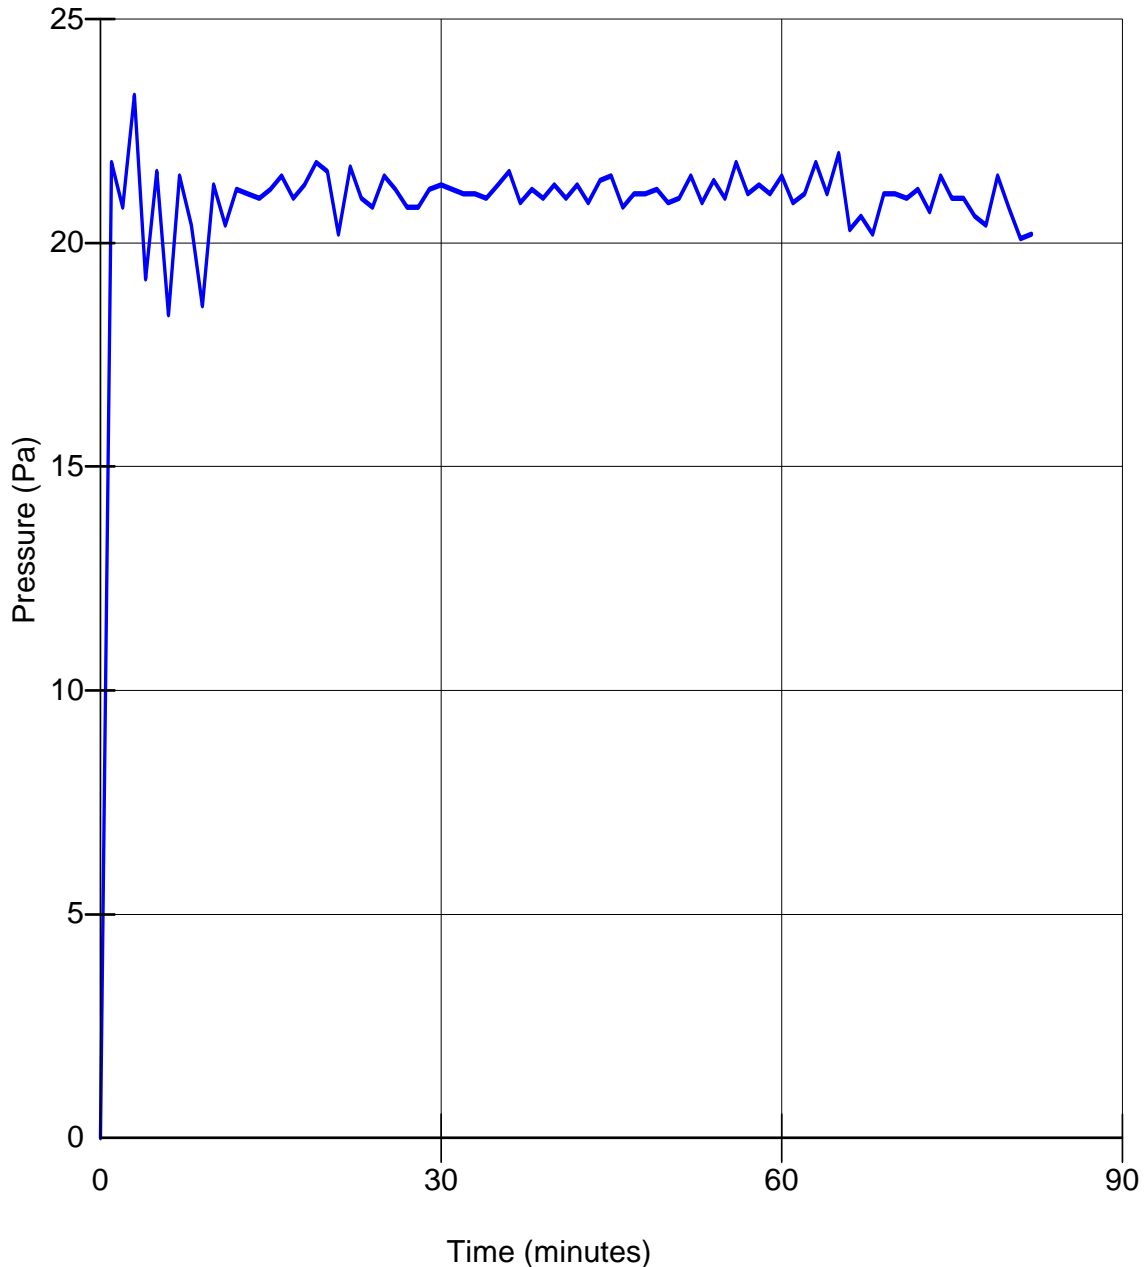
8.4 Furnace Pressure Graph

Figure 6. Pressure Graph.

The pressure was recorded at the top of the furnace. (The furnace pressure was set to control at 21.25 Pa at the top of the furnace, equating to 12.9 Pascals at the top of the doorsets).

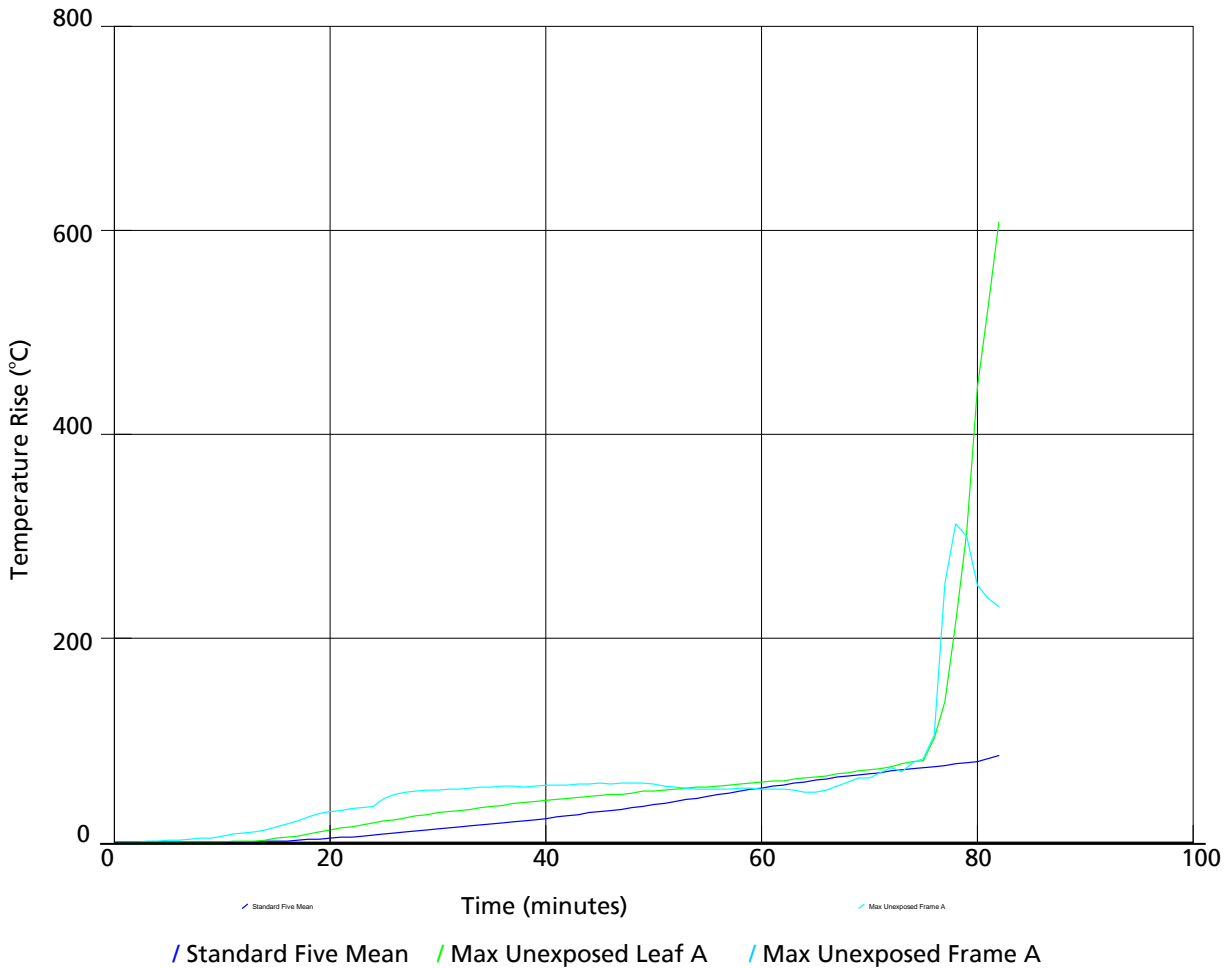
8.5 Doorset A Temperature Graph

Figure 7. Doorset temperature graph.

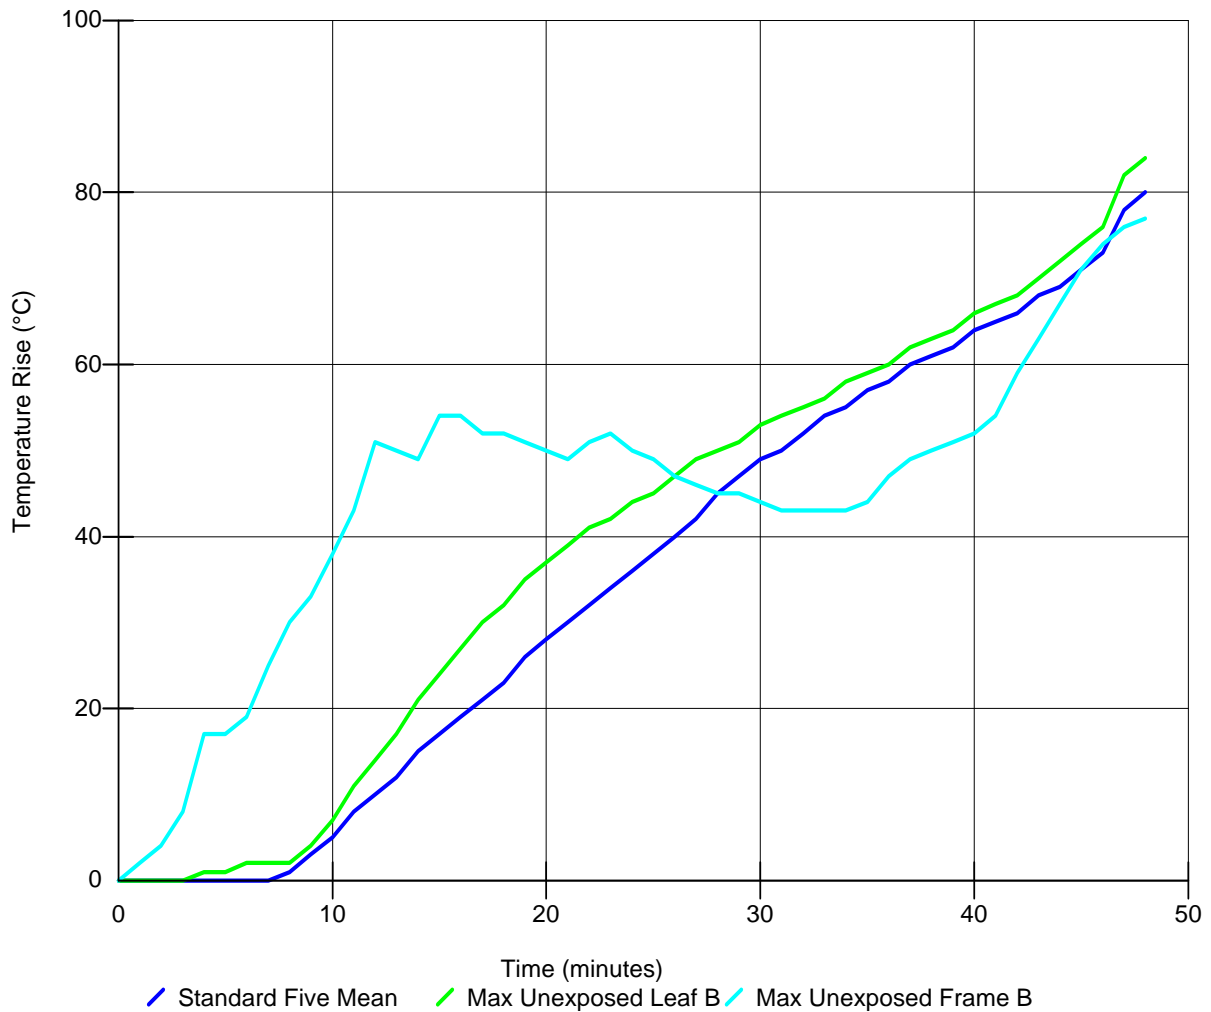
8.6 Doorset B Temperature Graph

Figure 8. Doorset temperature graph.

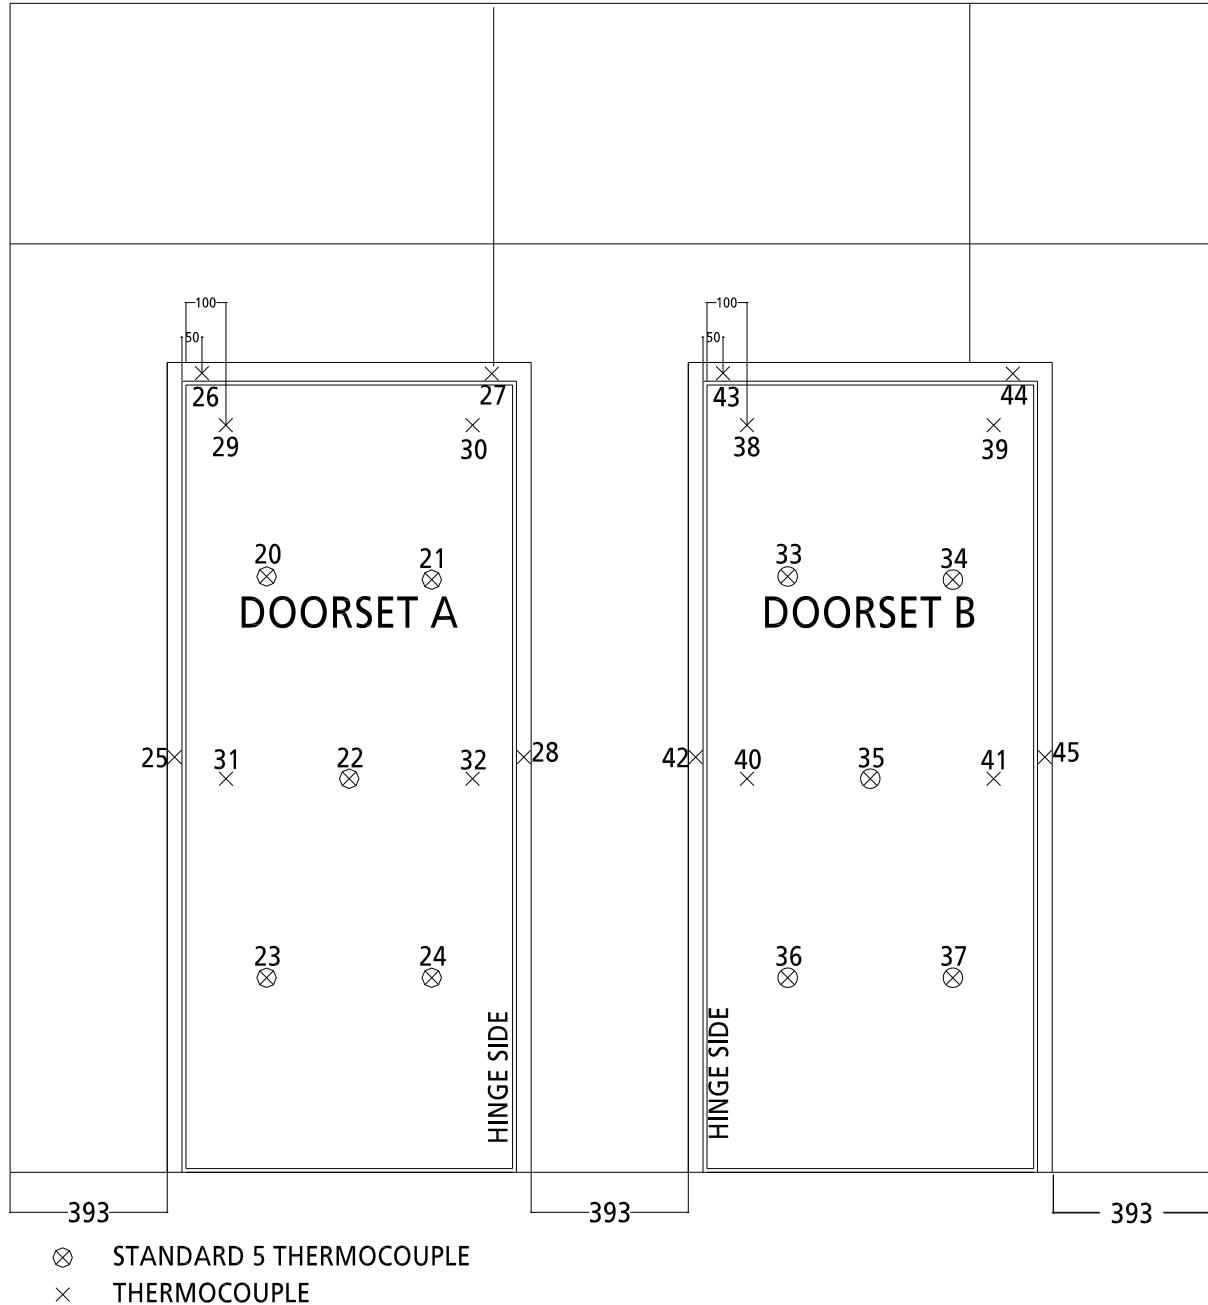
8.7 Unexposed Face Thermocouple Layout

Figure 9. Thermocouple layout.

See figure 9 for the location of the thermocouples.

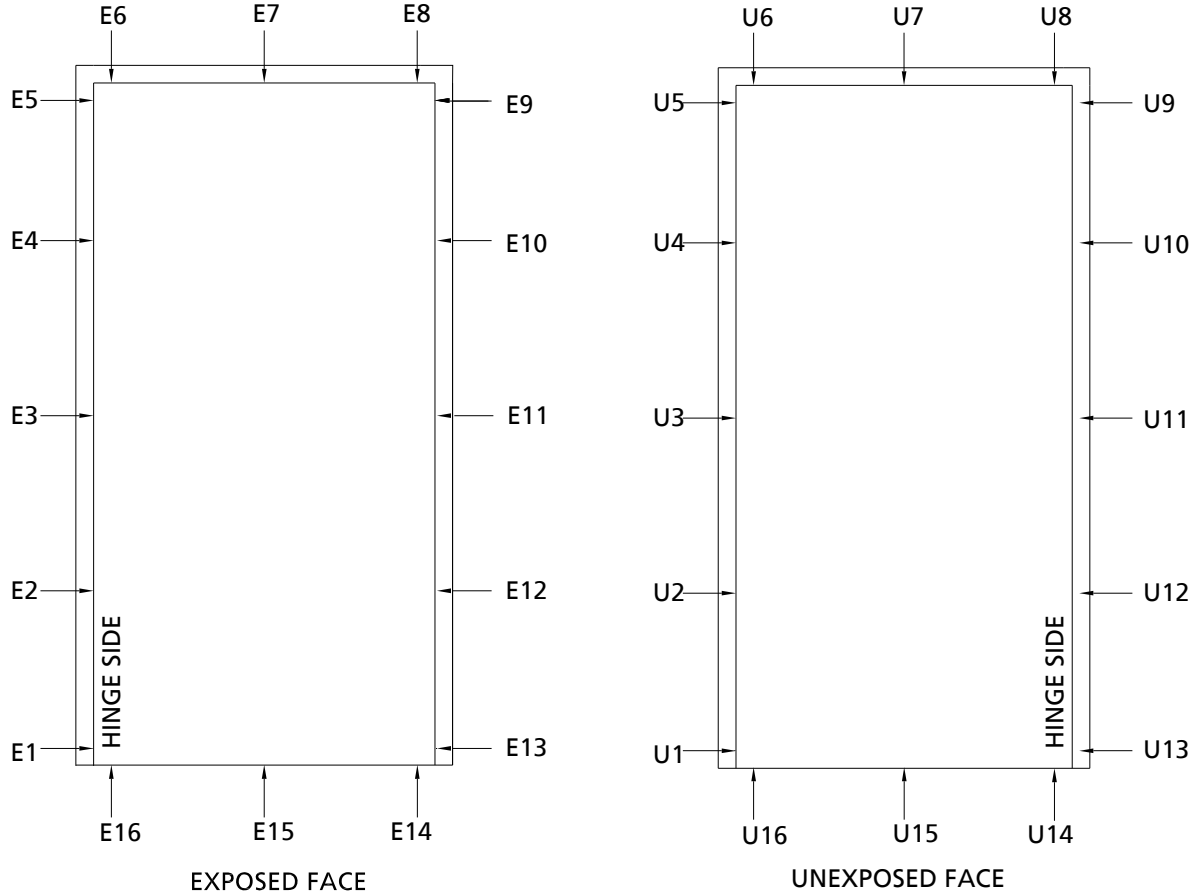
8.14 Doorset A Perimeter Gap Measurements

EXPOSED FACE		UNEXPOSED FACE		UNEXPOSED FACE		UNEXPOSED FACE	
Position	Gap (mm)	Position	Gap (mm)	Position	Gap (mm)	Position	Gap (mm)
E1	2.50	E9	3.60	U1	0.00	U9	0.45
E2	3.00	E10	4.00	U2	0.00	U10	1.00
E3	2.90	E11	3.60	U3	0.00	U11	2.50
E4	3.40	E12	4.90	U4	0.45	U12	1.00
E5	4.10	E13	5.20	U5	0.45	U13	1.25
E6	4.40	E14	6.30	U6	1.35	U14	6.70
E7	4.30	E15	5.80	U7	2.00	U15	4.80
E8	4.80	E16	6.40	U8	0.55	U16	5.50

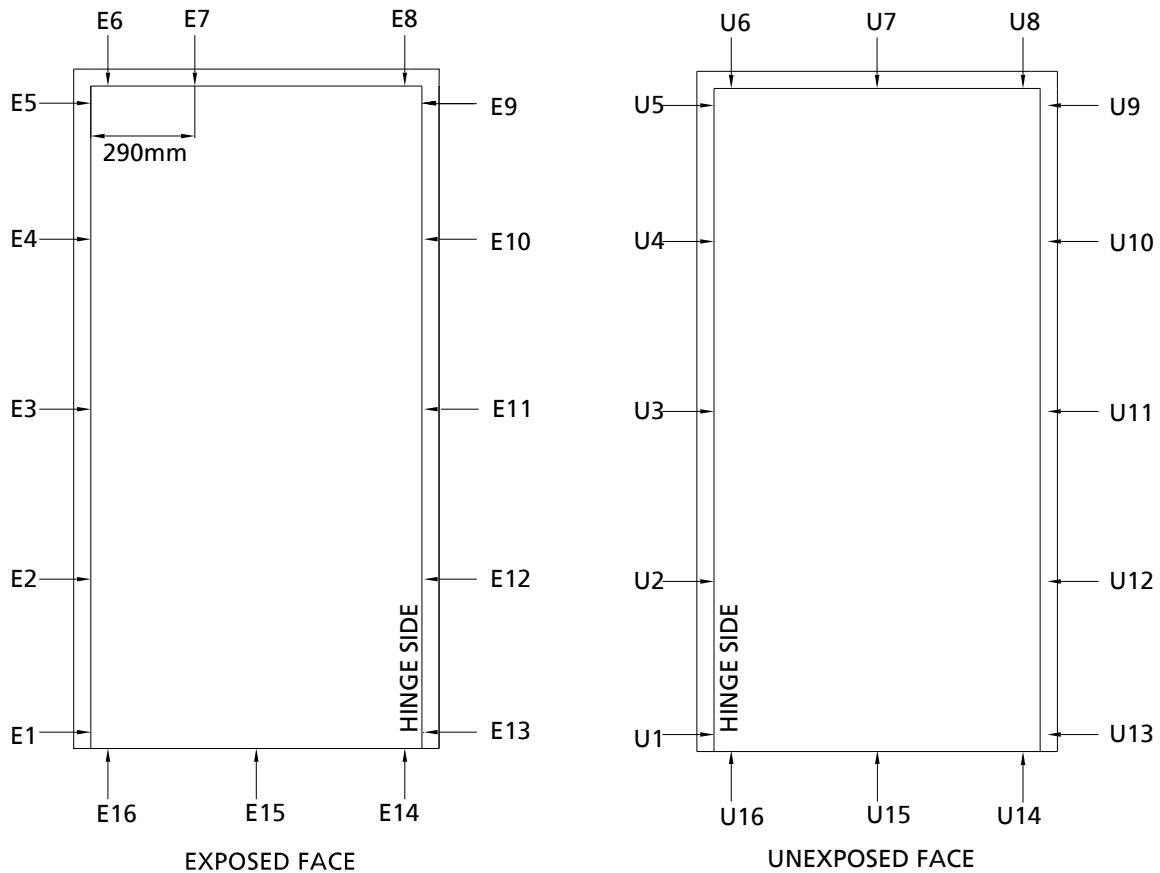
8.15 Doorset B Perimeter Gap Measurements

EXPOSED FACE				UNEXPOSED FACE			
Position	Gap (mm)	Position	Gap (mm)	Position	Gap (mm)	Position	Gap (mm)
E1	0.05	E9	0.60	U1	3.20	U9	3.60
E2	0.45	E10	1.15	U2	4.10	U10	3.70
E3	1.30	E11	1.00	U3	4.00	U11	3.80
E4	1.35	E12	1.90	U4	3.50	U12	4.90
E5	1.25	E13	0.55	U5	4.00	U13	4.10
E6	1.65	E14	6.10	U6	3.80	U14	6.40
E7	0.75	E15	6.20	U7	3.70	U15	6.40
E8	*	E16	6.40	U8	3.80	U16	5.80

*Gap could not be measured due to the position of the closer box and arm on the exposed face.

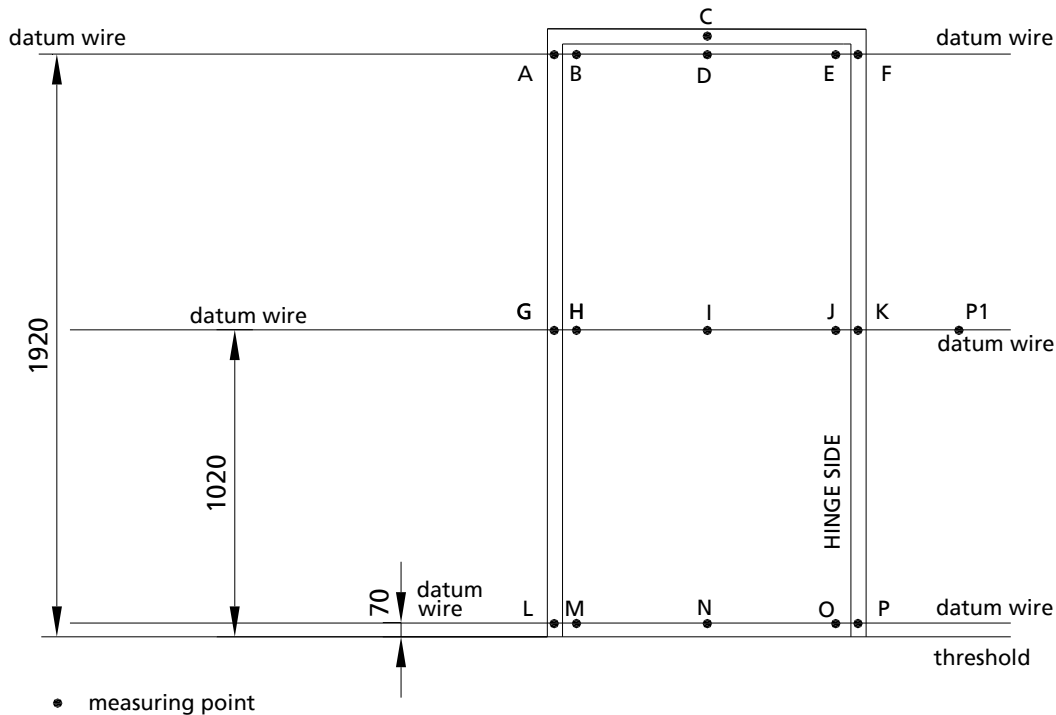
8.16 Doorset A Deflection Measurements

Time	A	B	C	D	E	F	G	H	I	J	K	L	M	N	O	P	P1
0	0	0	0	0	0	0	0	0	0	0	0	0	0	0	0	0	0
5	3	1	-5	2	0	4	3	3	5	4	4	-1	-4	-3	-1	10	3
11	4	3	1	4	2	4	3	6	6	6	4	-2	-3	-3	-1	9	4
16	5	4	4	4	2	6	3	6	7	5	4	-1	-3	-2	-1	12	4
20	6	4	3	5	4	7	4	7	7	5	5	0	0	-1	-2	9	4
25	5	6	4	5	4	6	5	8	8	6	6	0	0	-1	-2	9	4
30	5	7	-1	5	3	6	5	8	9	5	4	0	0	-2	-2	9	4
35	5	5	-1	4	2	6	3	10	9	5	4	0	1	-1	-2	10	3
41	5	6	-1	4	2	4	3	8	7	4	2	0	1	-3	-2	10	2
46	5	5	-2	4	2	4	3	7	5	3	2	0	0	-3	-2	10	2
53	5	5	-2	2	1	5	3	5	-2	-1	0	0	2	-3	-1	9	-
60	5	9	1	0	4	4	3	1	-13	-4	1	-1	4	-7	-1	13	-
65	5	10	-2	1	9	6	3	-2	-19	-5	2	0	5	-7	0	9	-
70	5	18	-1	2	11	7	3	-2	-23	-6	0	0	7	-8	2	10	-

The measurements were in mm and the time in minutes.

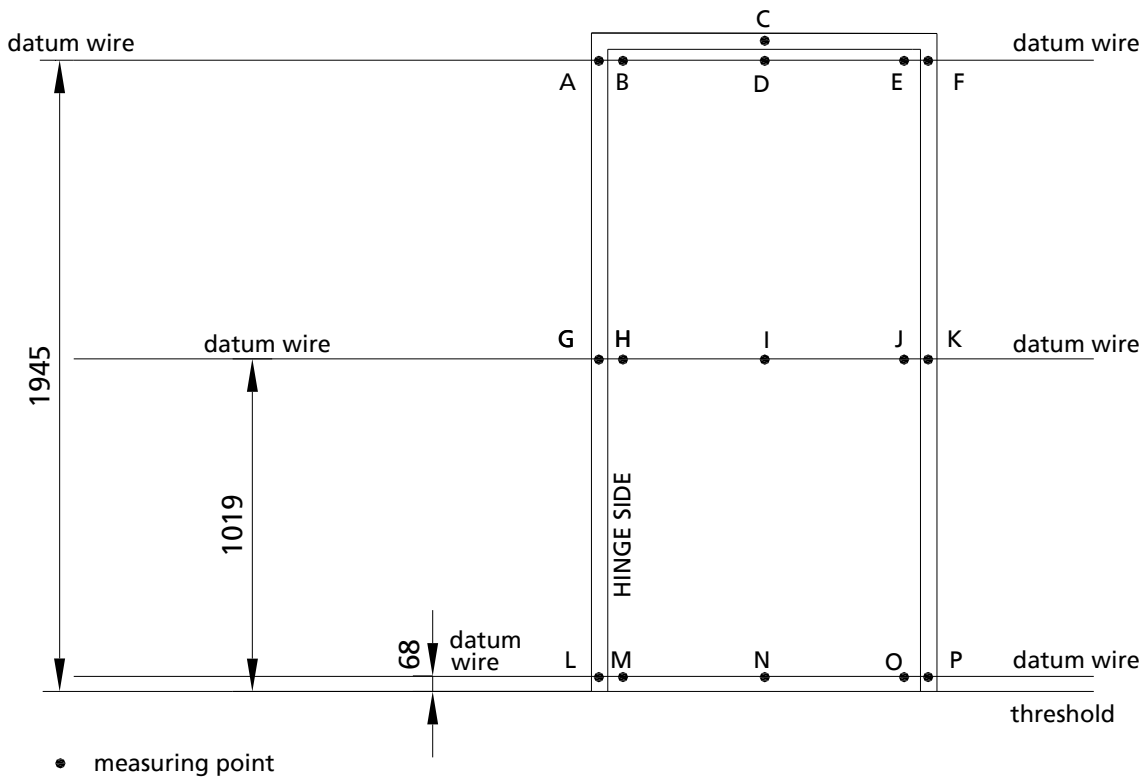
8.17 Doorset B Deflection Measurements

Time	A	B	C	D	E	F	G	H	I	J	K	L	M	N	O	P
0	0	0	0	0	0	0	0	0	0	0	0	0	0	0	0	0
7	3	1	1	0	0	2	2	2	3	1	11	0	-2	-4	-4	0
12	4	4	2	0	-2	0	2	1	4	-2	11	0	0	-3	-4	0
17	4	5	3	2	3	4	3	3	4	-1	13	-3	-1	-1	-1	0
22	4	6	3	4	4	5	2	3	2	-2	12	0	0	-1	0	0
25	5	6	2	4	4	5	2	1	-2	-2	14	0	0	-3	0	0
32	4	4	2	1	5	5	2	0	-3	-4	14	-1	-2	-7	0	0
37	3	4	1	-1	4	4	2	-6	-24	-7	14	0	-6	-16	-4	0
42	3	1	2	-3	3	4	1	-10	-31	-7	14	-1	-11	-25	-7	0
47	2	0	2	-6	2	-	-	-	-	-	-	-	-	-	-	-

The measurements were in mm and the time in minutes.

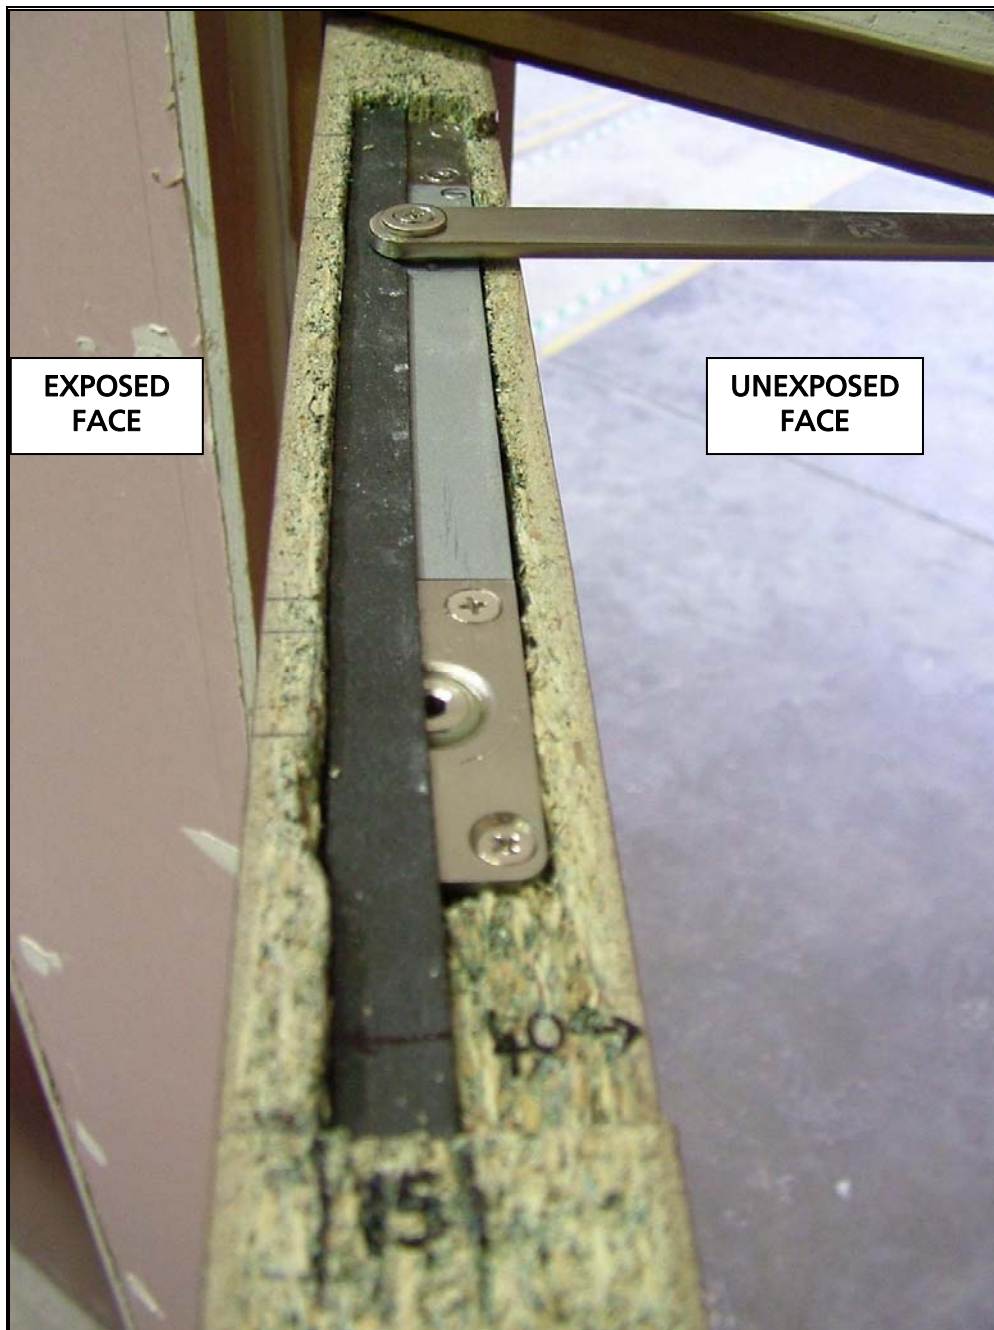
9.3 Doorset A – hanging edge head of door leaf, showing door closer and intumescent

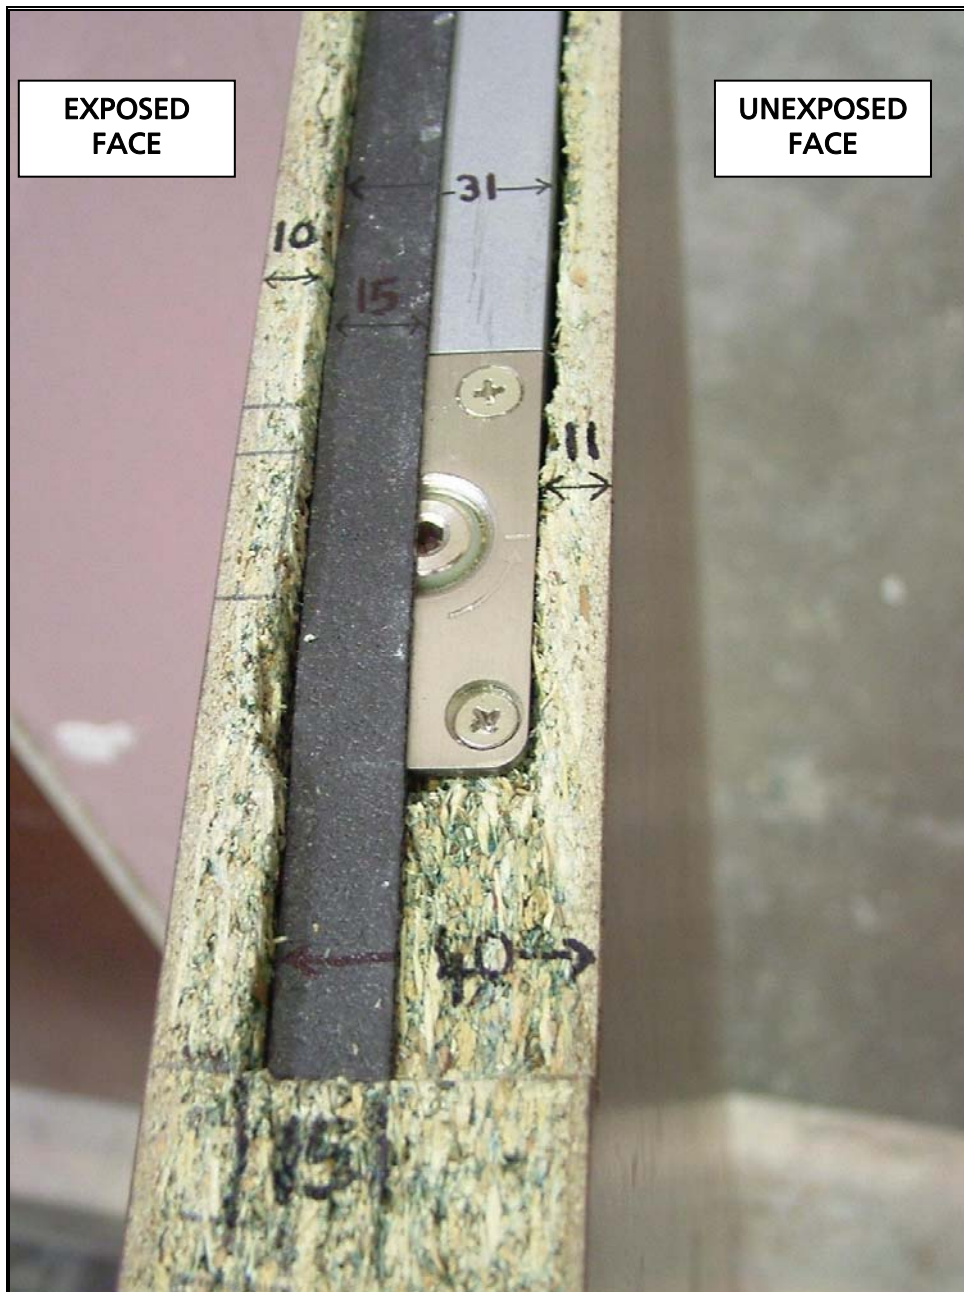
9.4 Doorset A - head of door leaf at hanging edge, showing dimensions

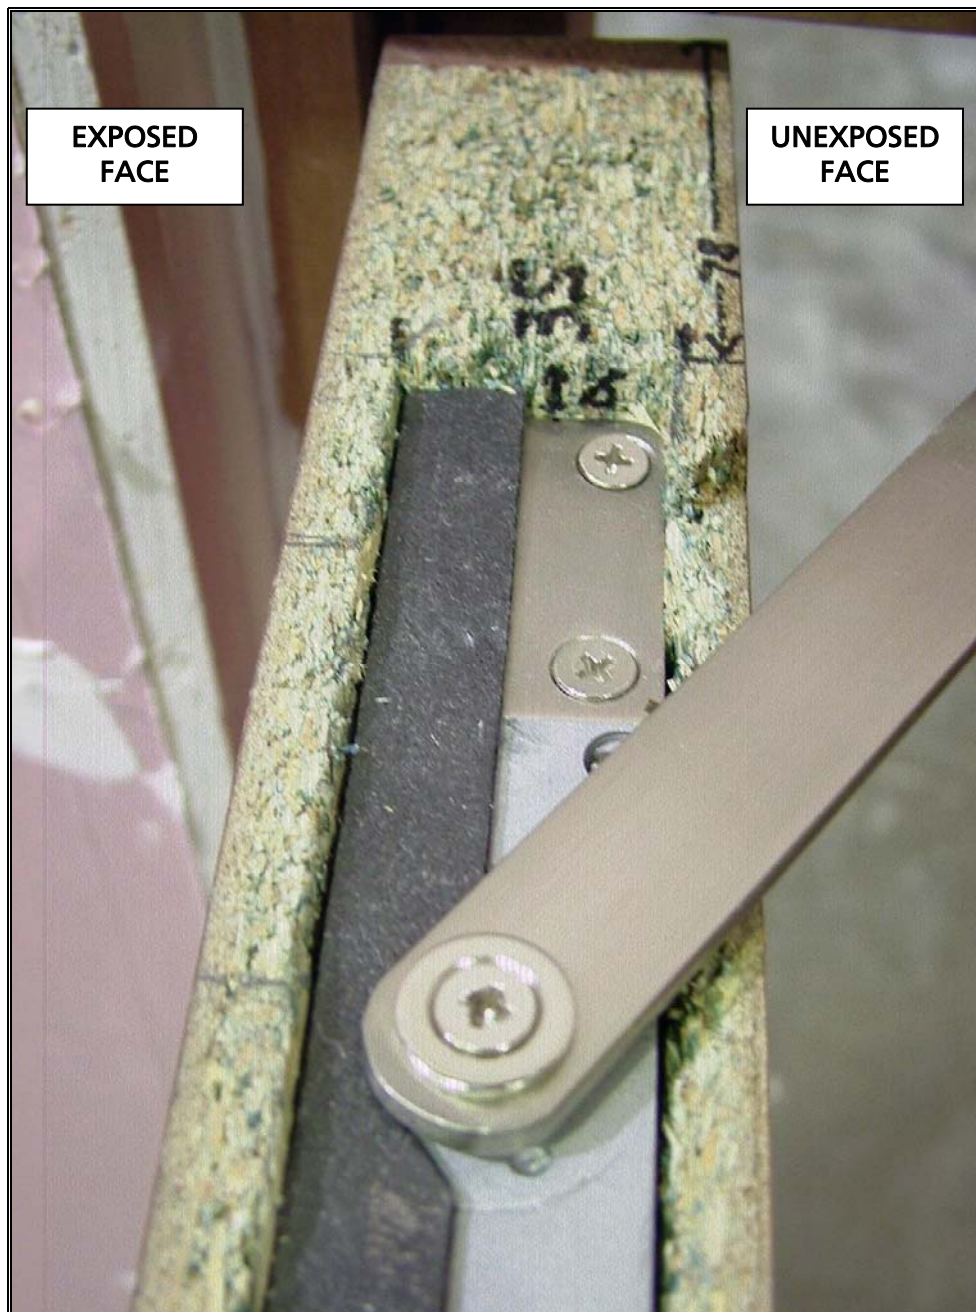
9.5 Doorset A – head of door leaf at hanging edge, showing dimensions

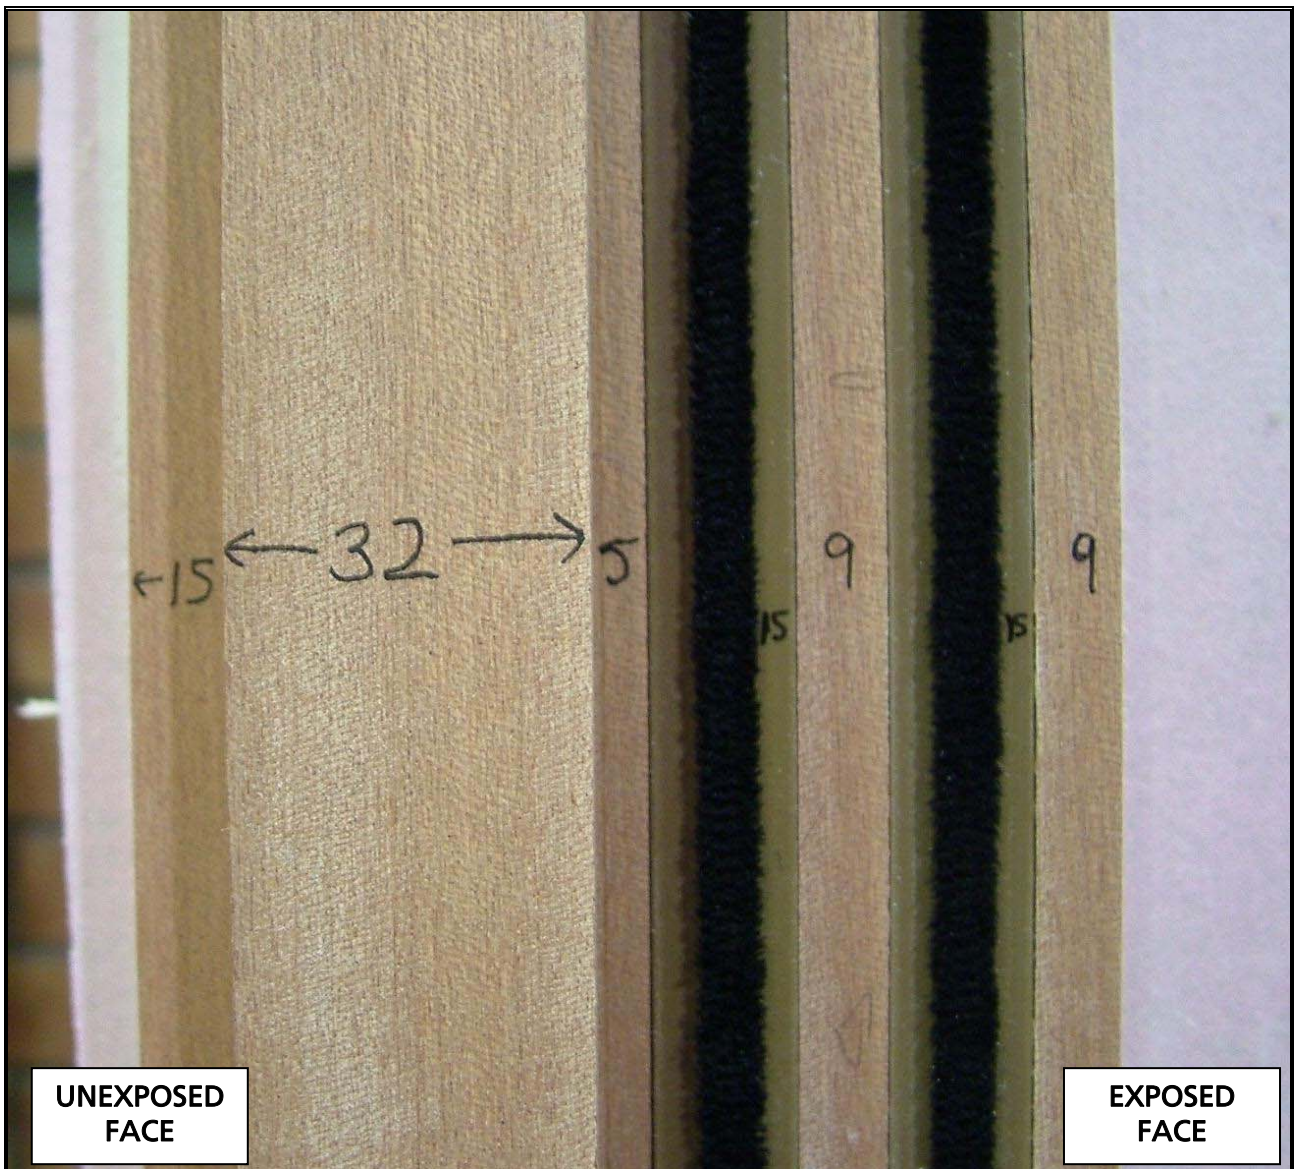
9.7 Doorset A – closing jamb of door frame showing doorstop and intumescent strips
