Report Number **BTC 16702F**

A FIRE RESISTANCE TEST, ON TWO SINGLE ACTING SINGLE LEAF DOORSETS, INCORPORATING DOOR CLOSERS BY RUTLAND UK, CONSTRUCTED IN A STANDARD FLEXIBLE SUPPORTING CONSTRUCTION, AND CONDUCTED IN ACCORDANCE WITH BS EN 1634-1: 2008.

Test Date: 8th December 2009

Customer: **Rutland UK**
Whittington Way
Chesterfield
S41 9AG

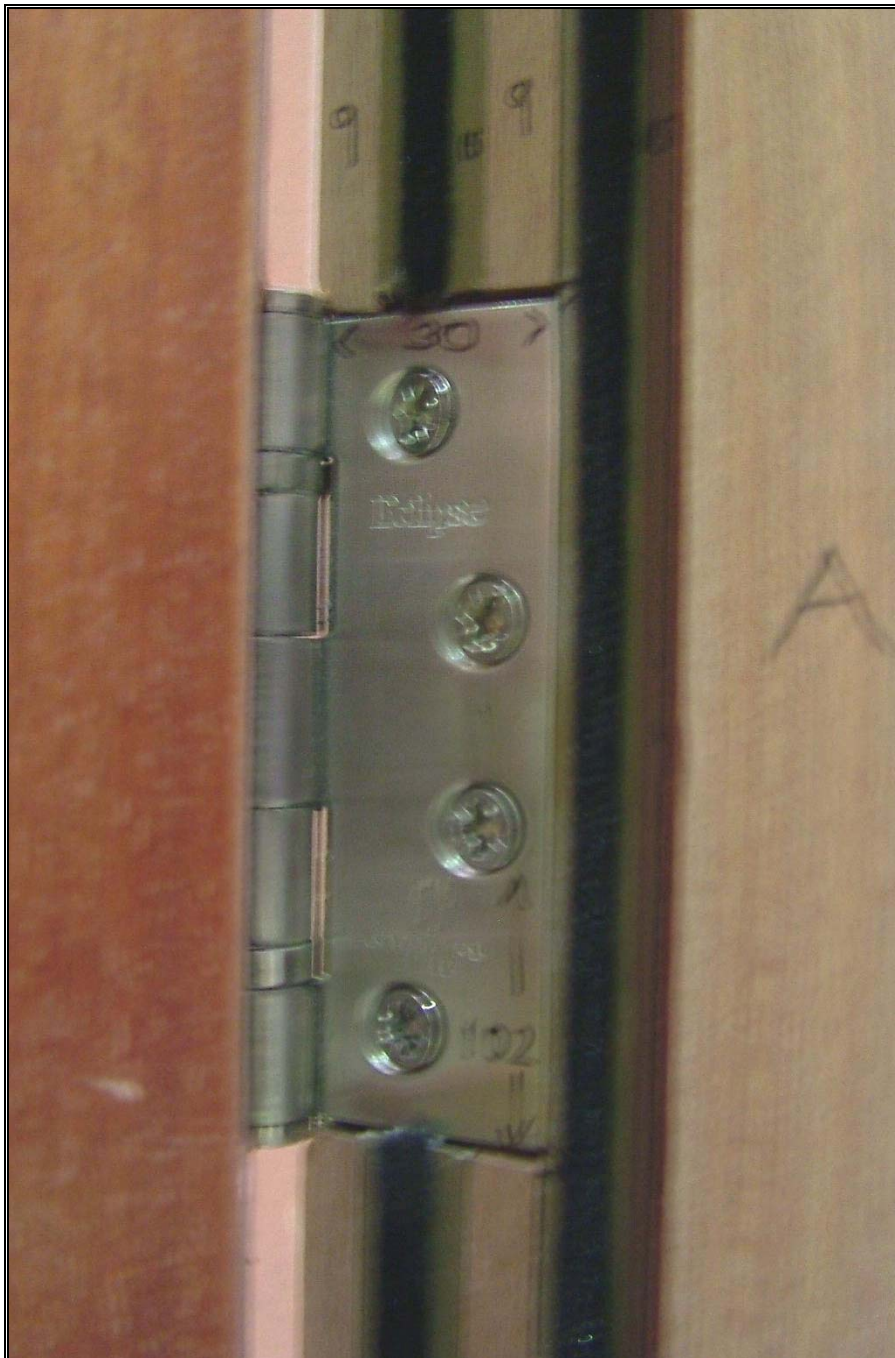
9.8 Doorset A – hinge and intumescent strips in door frame

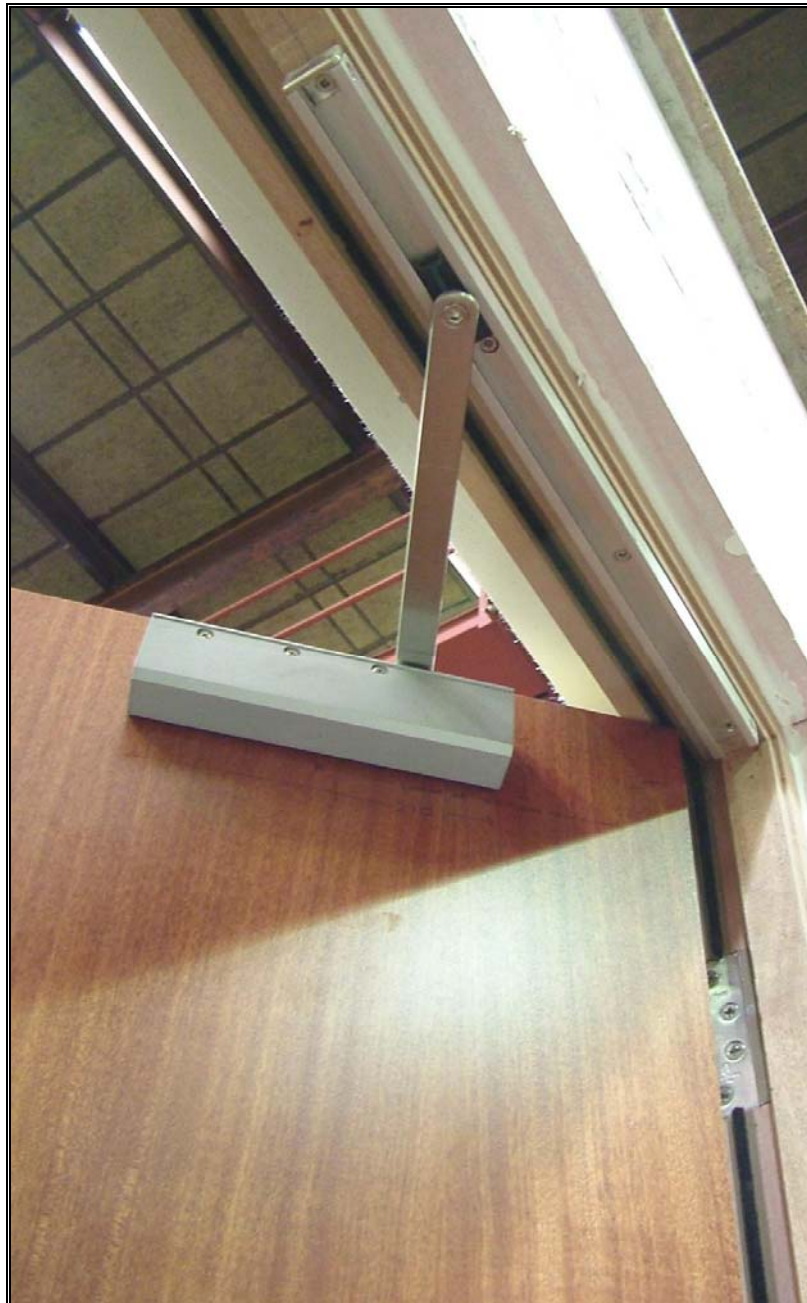
9.9 Doorset B – door closer on exposed face of door leaf

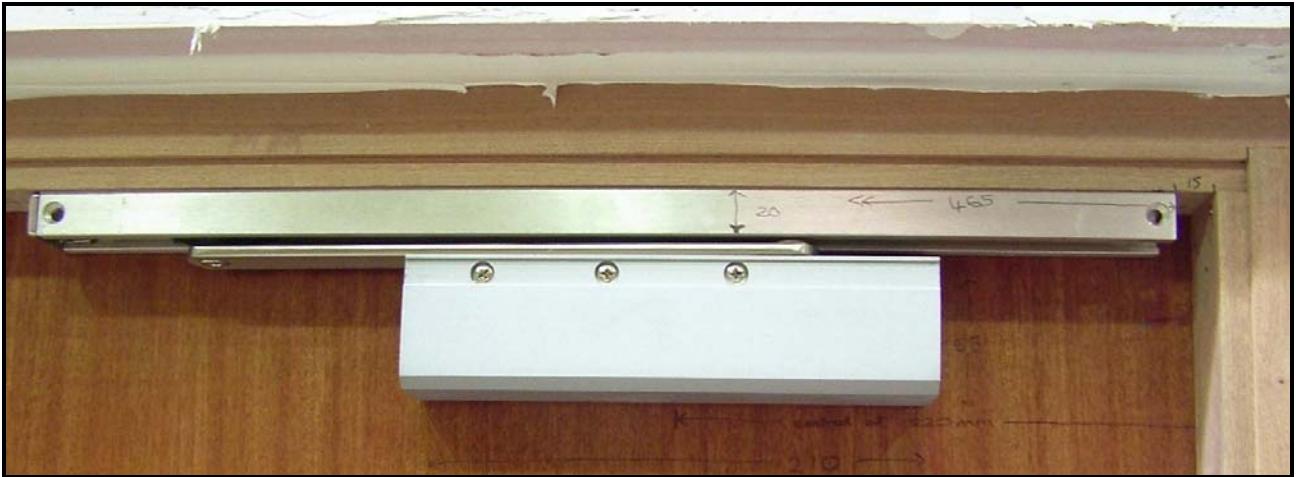
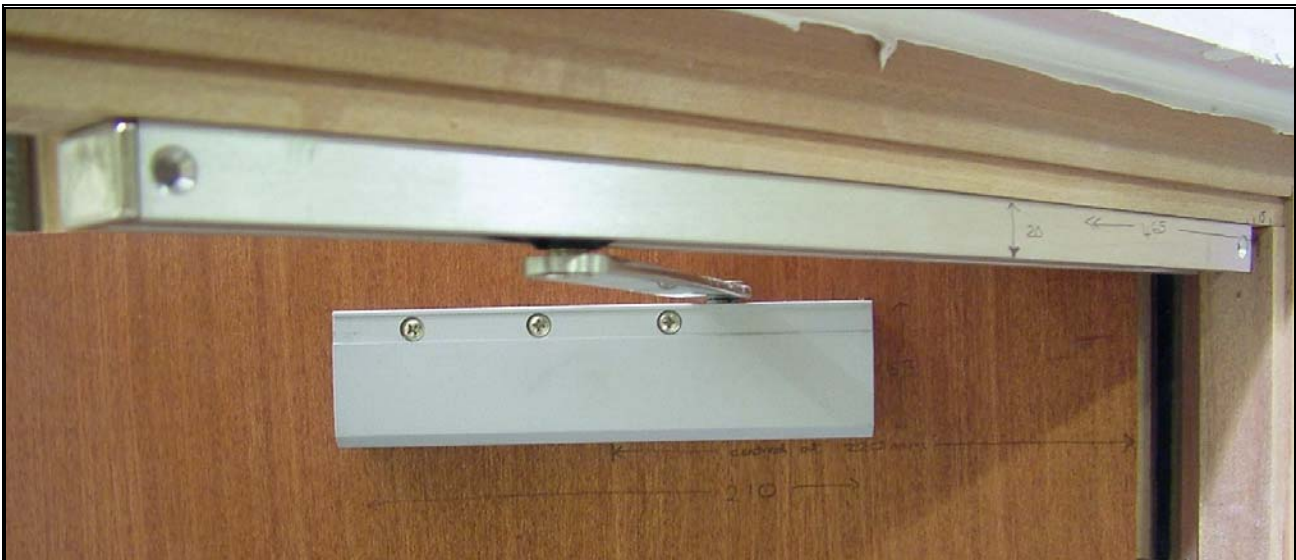
9.10 Doorset B – door closer, showing dimensions

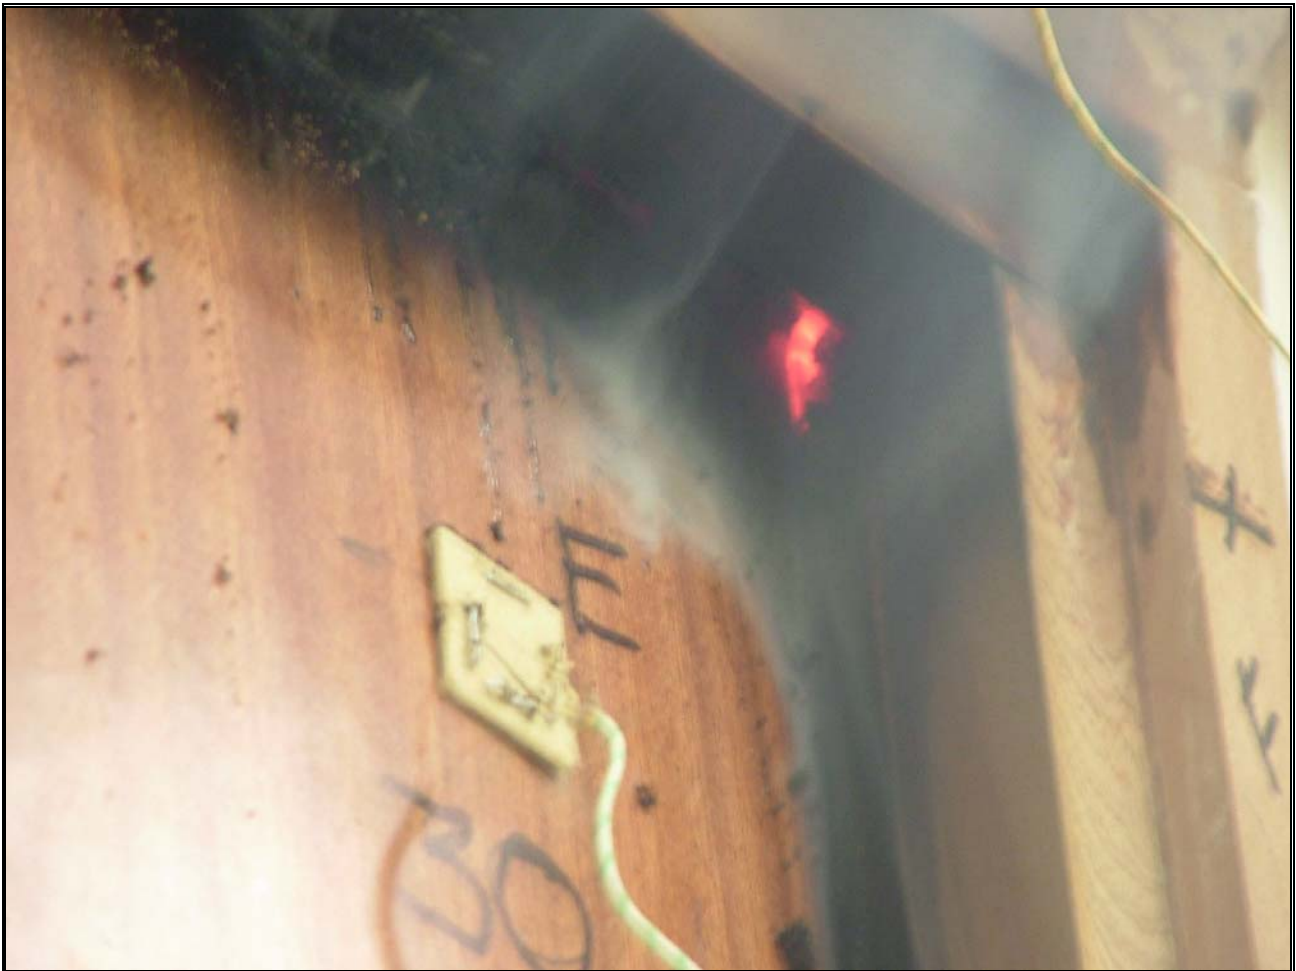
9.20 Doorset A – glow visible at hanging edge corner, at 1 hour, 7 minutes

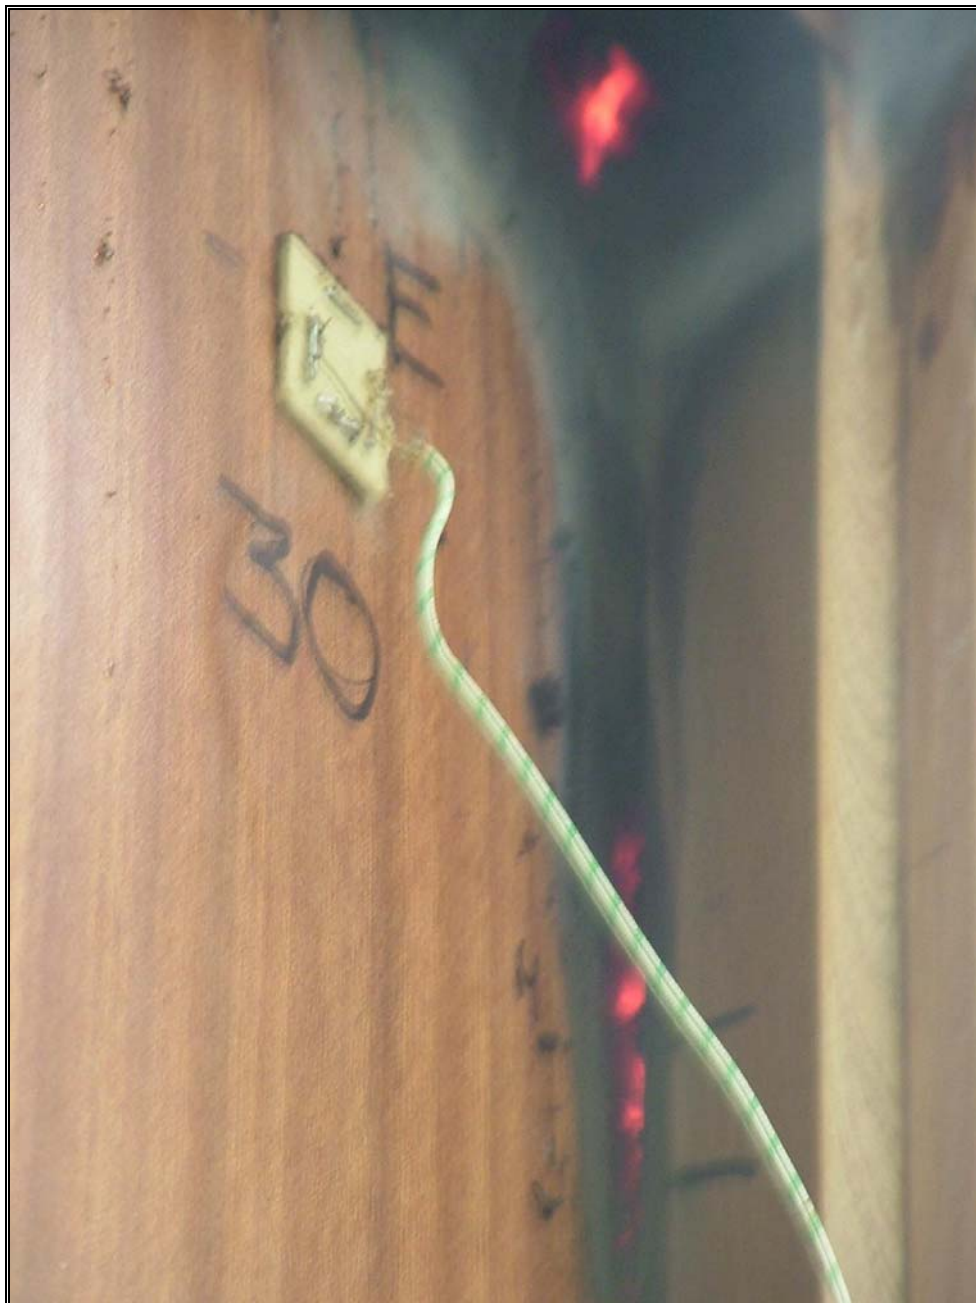
9.21 Doorset A – glow at corner and adjacent to top hinge, at 1 hour, 7 minutes

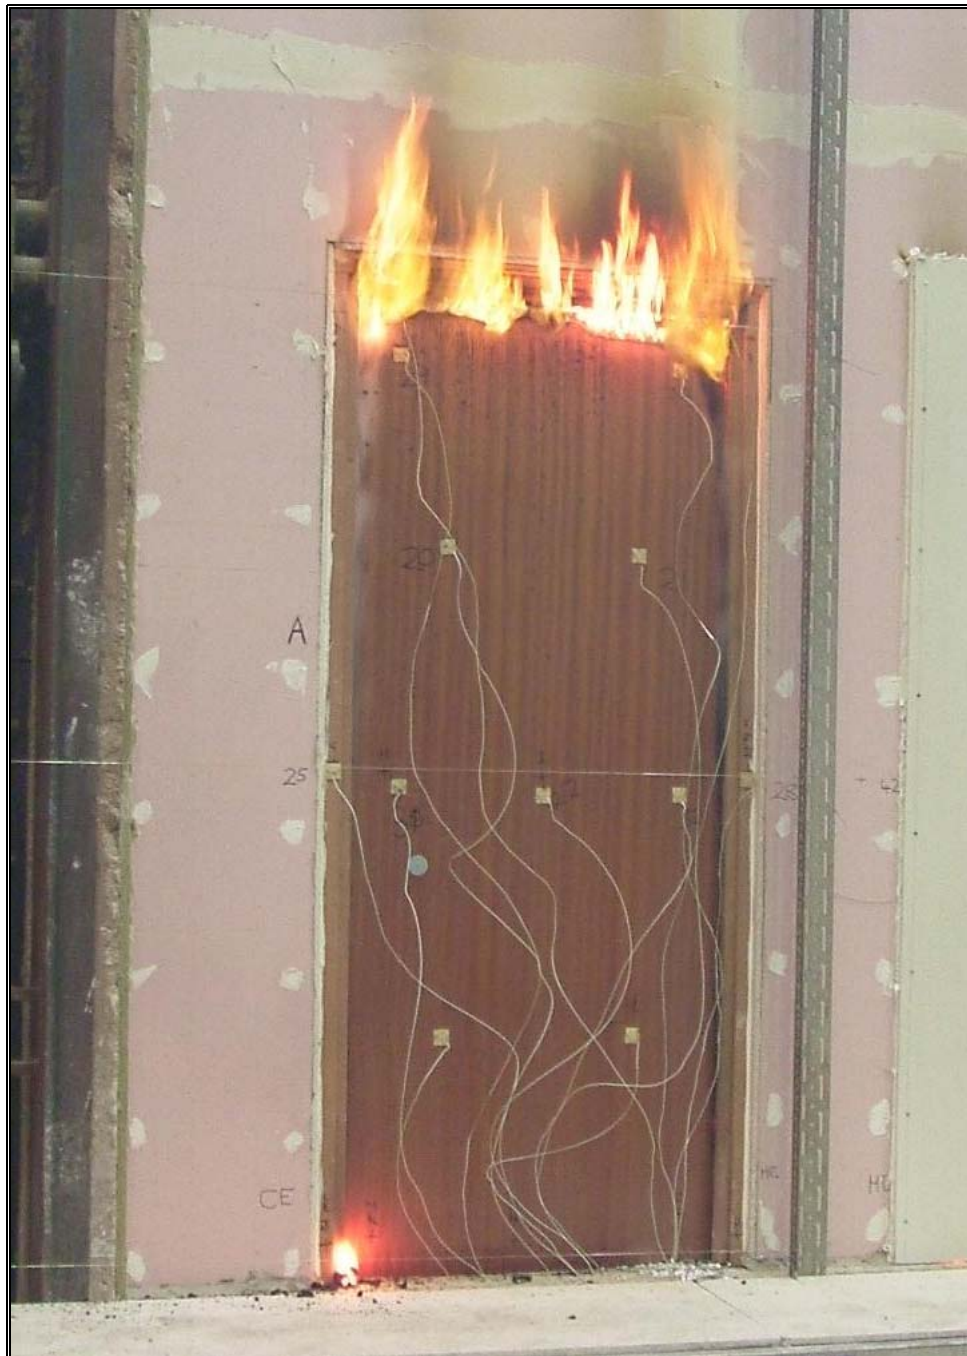
9.25 Doorset A – door leaf showing integrity failure, at 1 hour, 15 minutes

Integrity	Sustained flaming	75 minutes
	6mm gap gauge	77 minutes
	25mm gap gauge	78 minutes
	Cotton Pad	No Failure (the test having been discontinued at the request of the sponsor)
Insulation		75 minutes (by virtue of integrity failure)

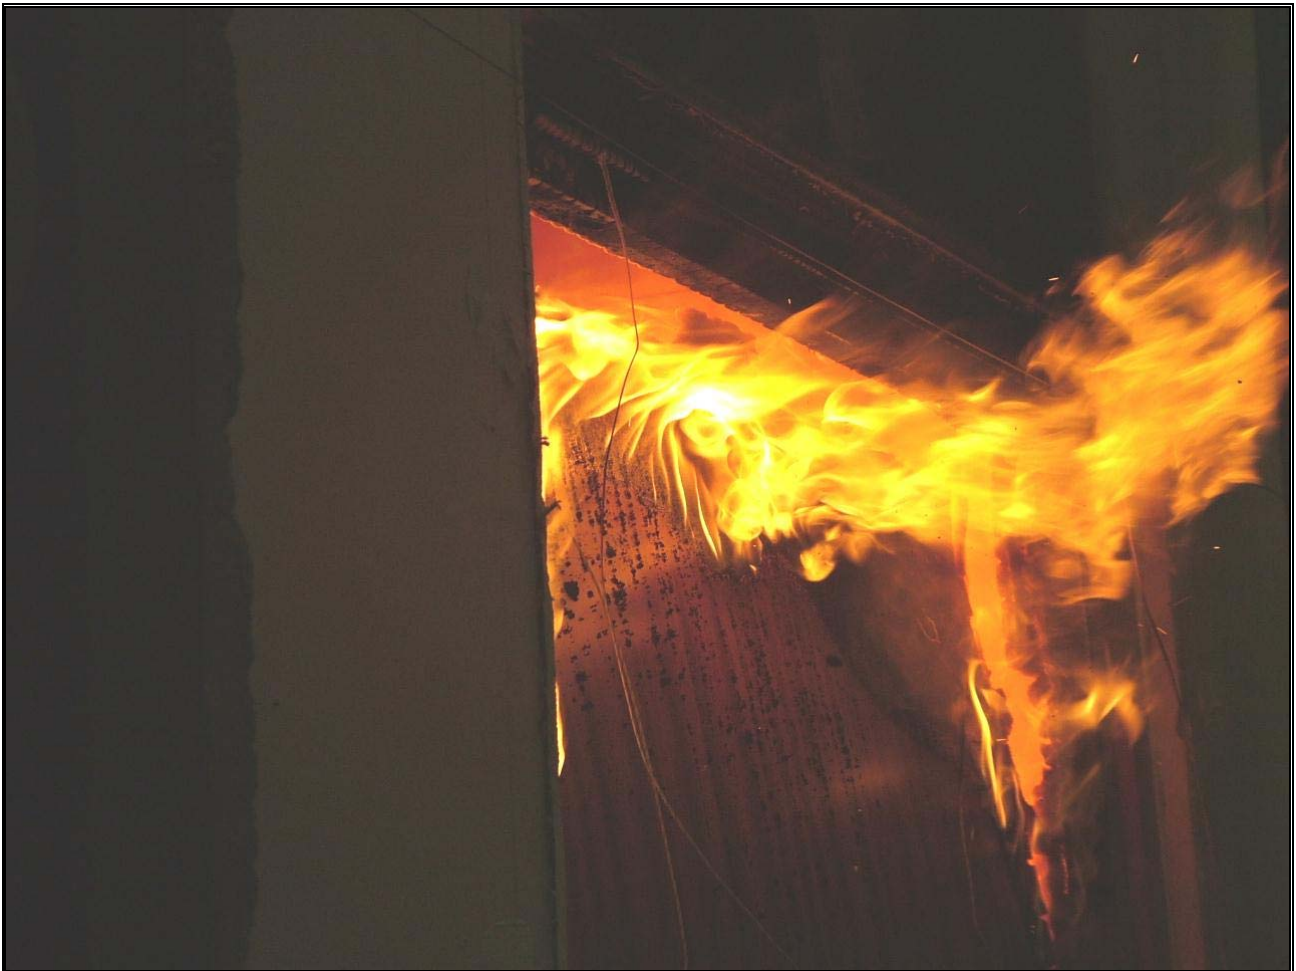
9.26 Doorset A – head of door leaf bowing into furnace at 1 hour, 20 minutes

1	18	Doorset A. Through gap visible at head of door leaf. <i>Unexposed face</i> Doorset A. FURTHER INTEGRITY FAILURE. The gap at the closing edge corner of the door leaf exceeded 25mm diameter (visual).
1	20	<i>Unexposed face</i> Doorset A. Top edge of door leaf bowed and started to fall into the furnace.
1	22	TEST TERMINATED at the request of the sponsor.
