test report

The fire resistance performance of a single-acting, single-leaf doorset, incorporating various items of building hardware, in accordance with BS EN 1634-1: 2000

161209

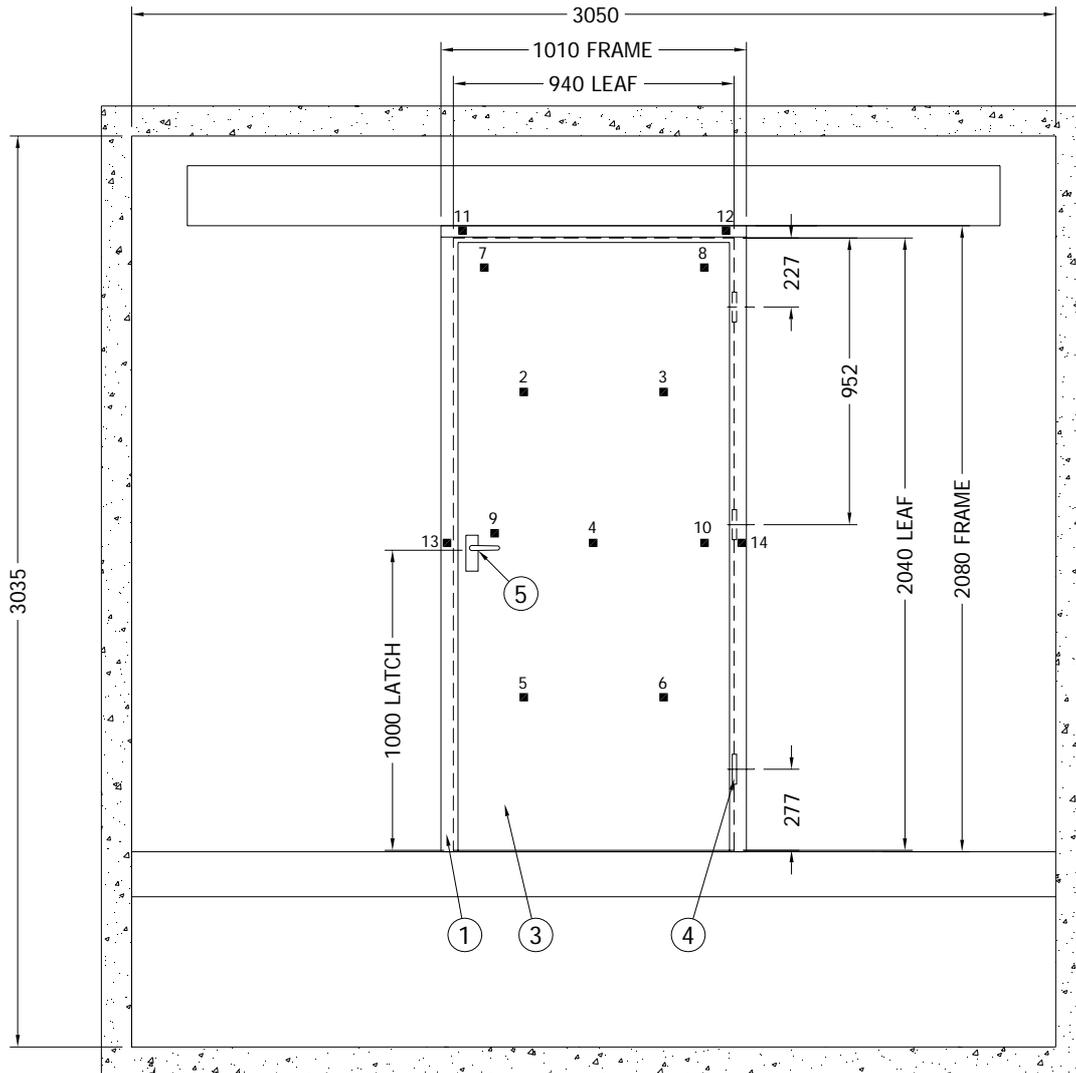
Figure 1- Elevation of unexposed face of doorset

- POSITIONS OF UNEXPOSED FACE THERMOCOUPLES.

SPECIMEN BUILT INTO A MASONRY WALL CONSISTING OF AAC (AUTOCLAVED AERATED CONCRETE) BLOCKWORK WALL, LINTEL AND BASE, NOMINALLY 200 THICK. DOOR LEAF OPENS AWAY TOWARDS THE HEATING CONDITIONS OF THE TEST.

General	The instrumentation was provided in accordance with the requirements of the Standard.
Furnace	The furnace was controlled so that its mean temperature complied with the requirements of BS EN 1363-1: 1999 Clause 5.1 using six plate thermometers, distributed over a plane 100 mm from the surface of the test construction.
General	Thermocouples were provided to monitor the unexposed surface of the specimen and the output of all instrumentation was recorded at no less than one minute intervals as follows:
Thermocouples 2 to 6	At five positions on the doorset, one approximately at the centre and one at approximately the centre of each quarter section of the doorset.
Thermocouples 7 to 10	At four positions on the doorset, positioned at 100 mm in from the door leaf vertical edges, two at mid-height, and two at 100 mm below the top edge of the leaf.
Thermocouples 11 to 14	At four positions on the door frame, one positioned 50 mm away from both vertical edges of the door leaf on the top horizontal frame member and one positioned on each vertical frame member at mid-height. The locations and reference numbers of the various unexposed surface thermocouples are shown in Figure 1.

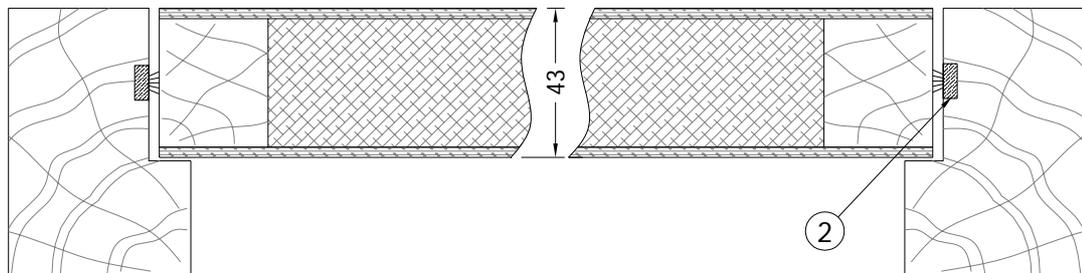
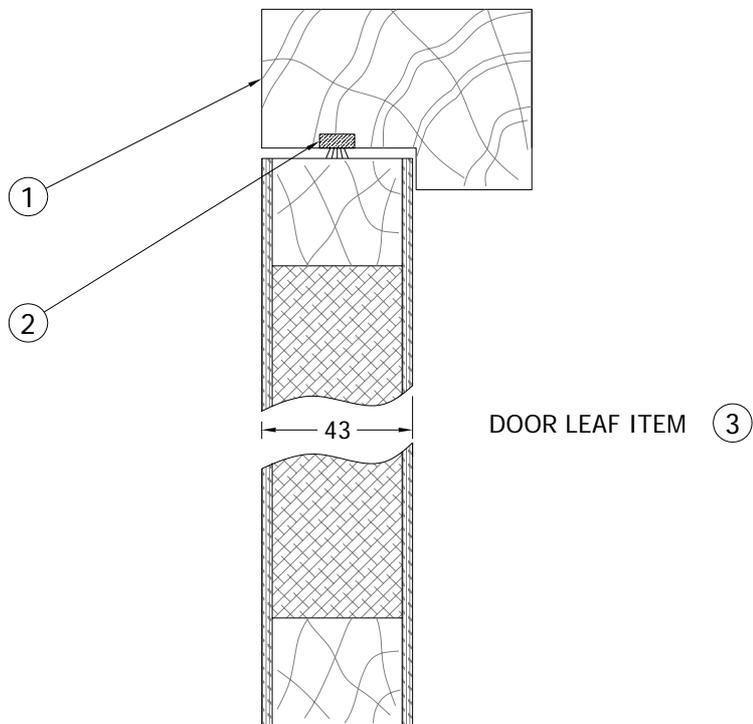
Figure 2 – Horizontal and vertical sections through doorset

HORIZONTAL SECTION

VERTICAL SECTION

DOOR LEAF - OPENS TOWARDS THE HEATING CONDITIONS OF THE TEST.

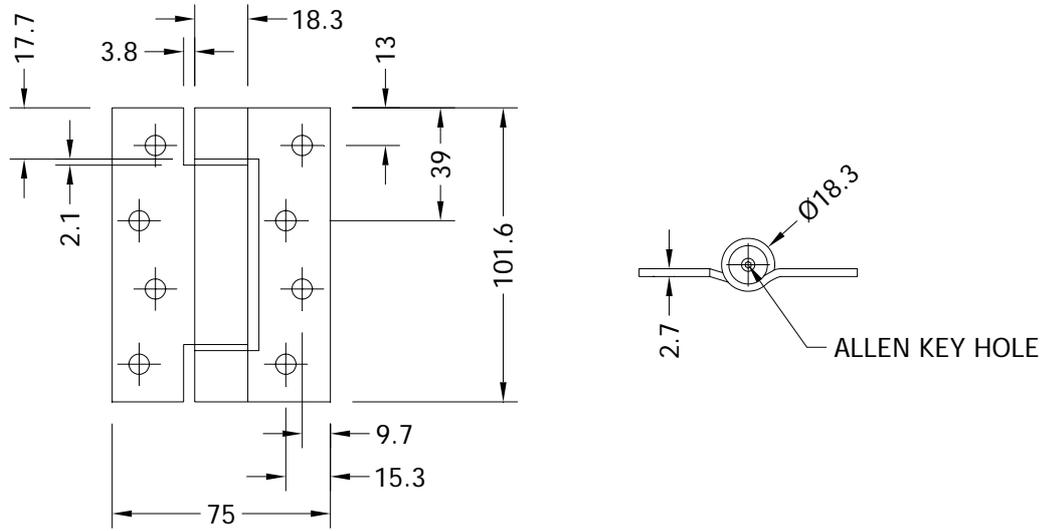
HINGE - ITEM 4

v. lippings	: Hardwood to vertical edges
4. Hinges	
Manufacturer	: Frelan Hardware
Reference	: J9800, self closing hinges
Material	: Mild steel with polished chrome finish
Overall sizes

i. knuckle	: 101.6 mm long x 18.3 mm diameter
ii. blades	: 101.6 mm long x 75 mm wide overall x 2.7 mm thick
Fixings	
i. type	: Countersunk screws
ii. material	: Steel
iii. size	: 38 mm long x 4.8 mm diameter

iv. number off per blade	: 4 off
v. maximum distance of fixing screws from exposed face of door leaf	: Approximately 18 mm
Bedding material	
i. reference / material	: Interdens intumescent seal behind each hinge flap
ii. size	: 1 mm thick x blade size
Maximum opening moments	: 21 Newton metre (Nm), of three hinges combined
Maximum closing moments	: 6 Nm, of three hinges combined

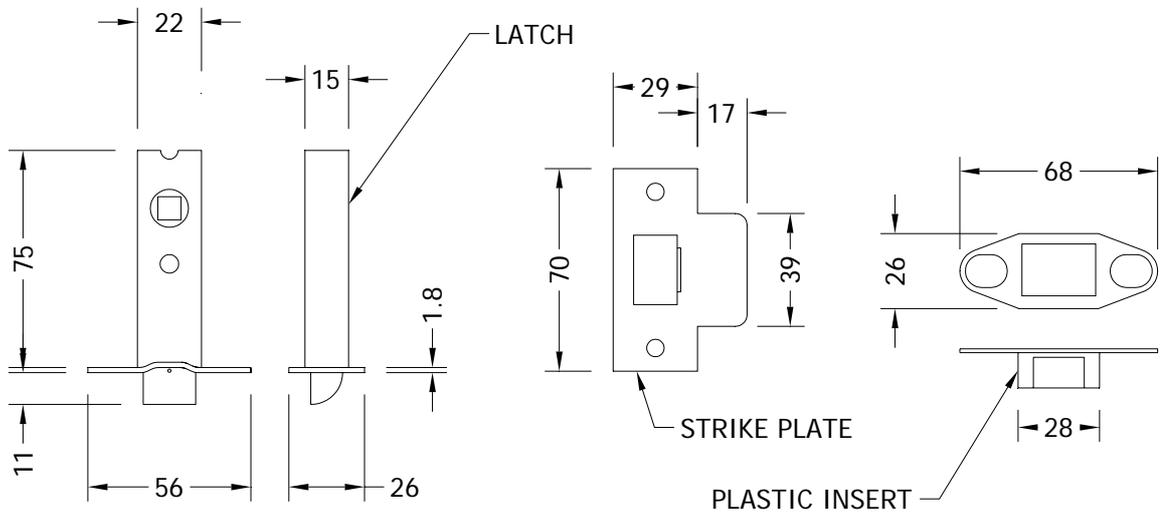
LATCH - ITEM 5

Manufacturer	: Frelan Hardware
Reference	: JL6666
Material	: Mild steel latch and strike plate with plastics insert behind the strike plate
Overall size	
i. latch casing	: 75 mm long x 22 mm deep x 15 mm wide
ii. latch bolt throw	: 11 mm
ii. strike plate	: 70 mm x 29 mm
iii. plastics insert	: 68 mm x 26 mm
Operation of latch bolt	: Engaged
Fixings	
i. type	: Countersunk screws
ii. material	: Steel
iii. size	: 25 mm long x 4 mm diameter
iv. number off	: 2 off each for the latch & strike plate
Bedding material	
i. reference	: Firestop 400
ii. material	: Intumescent mastic
Lever handles	
i. manufacturer	: Magnet
ii. material	: Brass
iii. reference	: Victorian 0220
iv. overall size	: 104 mm long x 19 mm diameter tapering to 11 mm, complete with 120 mm x 41 mm backing plate

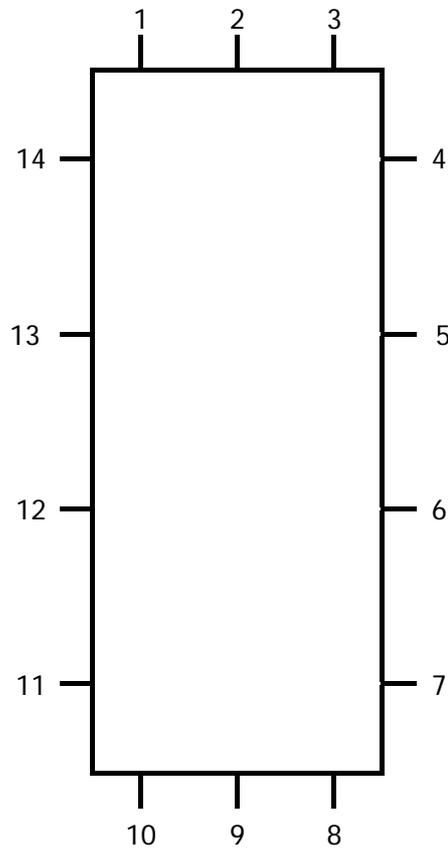
Doorset clearance gaps

View from unexposed face

Gap Dimension in mm at Position														
1	2	3	4	5	6	7	8*	9*	10*	11	12	13	14	
2.4	2.7	2.6	3.6	3.6	3.6	3.8	10.0	10.0	10.0	3.5	3.0	3.2	2.7	
Mean			3.2		Maximum			3.8		Minimum			2.4

Gap Between Face of Leaf and Doorstop in mm at Position													
1	2	3	4	5	6	7	8#	9#	10#	11	12	13	14
0.5	0.5	0.5	1.0	1.0	1.0	1.0	-	-	-	0.95	0.95	0.85	0.85

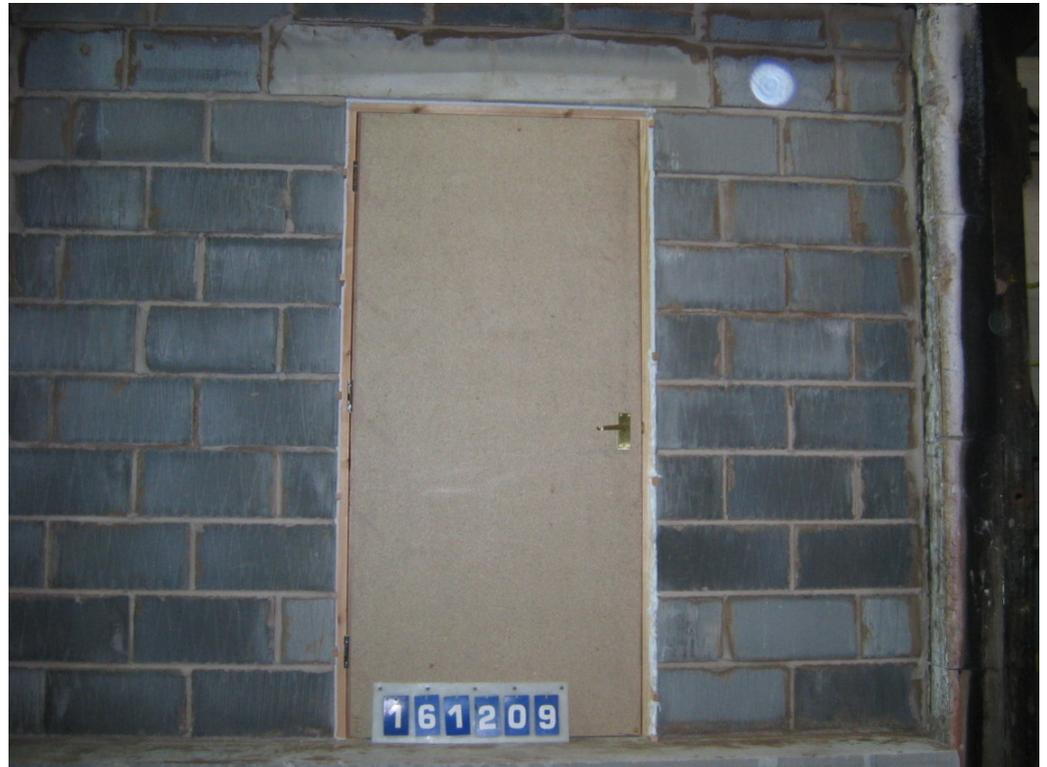
The exposed face of the doorset prior to testing

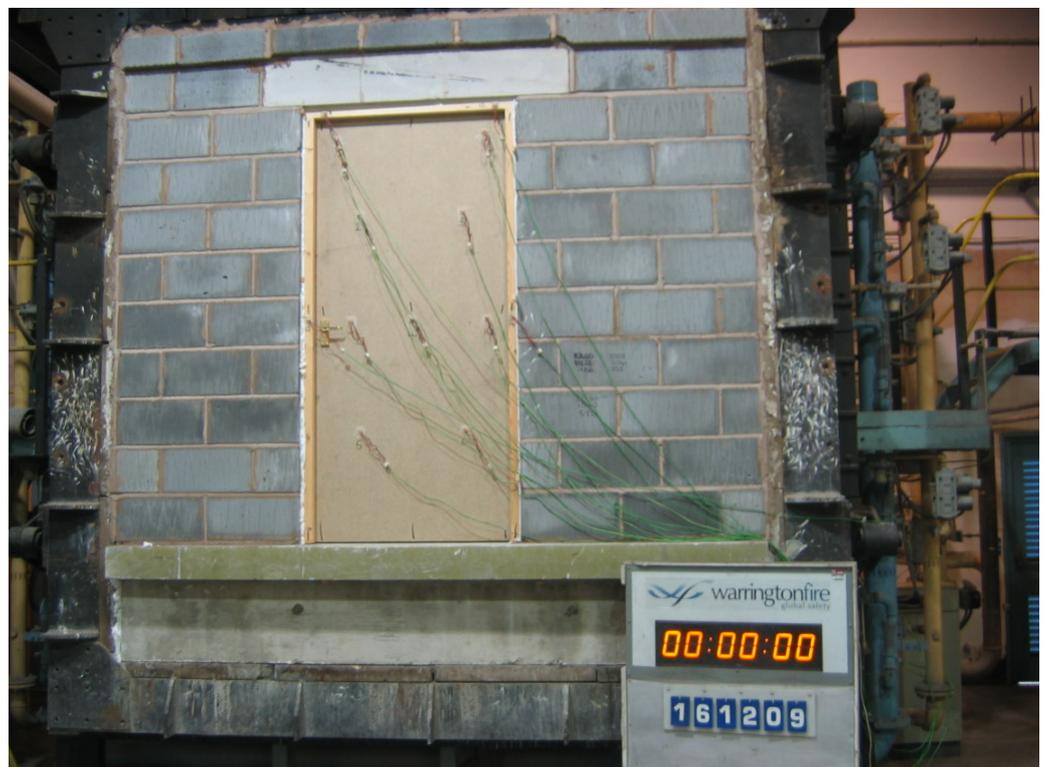
The unexposed face of the doorset prior to testing

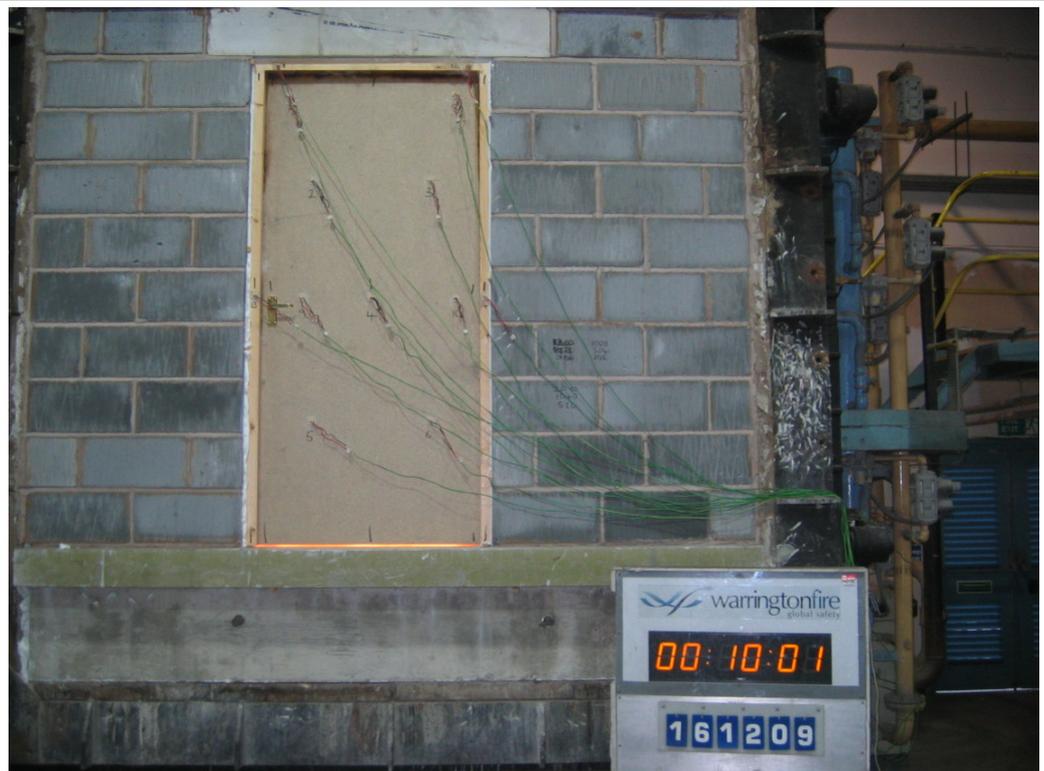
The unexposed face of the doorset after 10 minutes of testing

Time		All observations are from the unexposed face unless noted otherwise.
mins	secs	The ambient air temperature in the vicinity of the test construction was 12°C at the start of the test with a maximum variation of 2°C during the test.
00	00	The test commences.
01	40	Smoke issue commences from the head and fixed edge of the doorset, (fixed edge from the top hinge position to the head).
03	30	Smoke issue has ceased from the areas mentioned at 1 minute, 40 seconds.
06	30	Smoke issue resumes at the head and top hinge position and at one area of the leading edge at $\frac{3}{4}$ height next to thermocouple No.2.
08	00	Discolouration of the door leaf at positions of smoke issue.
09	00	Smoke issue has started above and below the latch position on the leading edge.
11	00	Smoke issue has slowed at the head and at the top hinge position.
15	00	The leading edge is beginning to move away from the doorstop at the threshold up to approximately 300 mm. The gap at the threshold is approximately 15-20 mm.

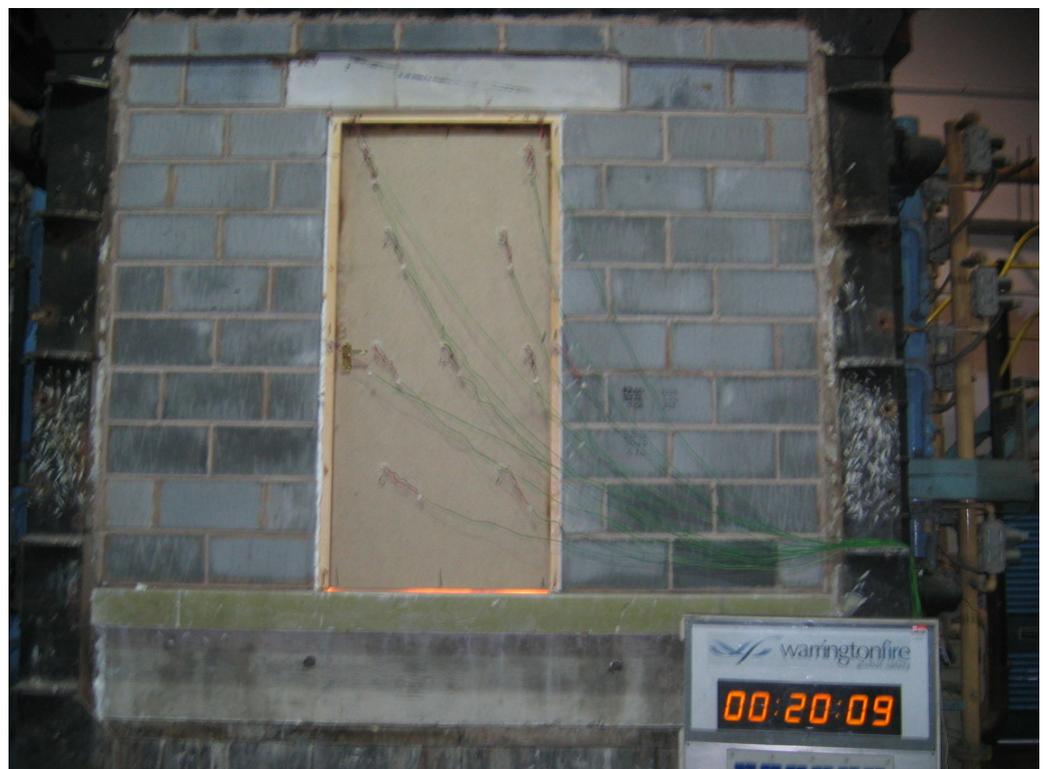
The unexposed face of the doorset after 20 minutes of testing

16	00	The same has happened at the head of the leading edge, the gap is approximately 300 mm. The movement extends across the head to approximately mid-span of the leaf and approximately 300 mm down the leading edge.
19	00	Discolouration is occurring on the door leaf at the bottom hinge position.
20	00	The threshold of the door leaf at its hinged edge has moved away from the stop by approximately 5-10 mm.
21	00	Smoke issue is increasing from the latch position.
22	00	The gaps between leaf and stop at the threshold and head of the leading edge are increasing, approximately 15 mm at threshold and 10 mm at head.
23	00	Gaps between leaf and stop at the threshold and head of the hinged edge are increasing both approximately 5mm.
28	00	Reacted intumescent is visible at the threshold of the leading edge as a result of the movement previously mentioned.

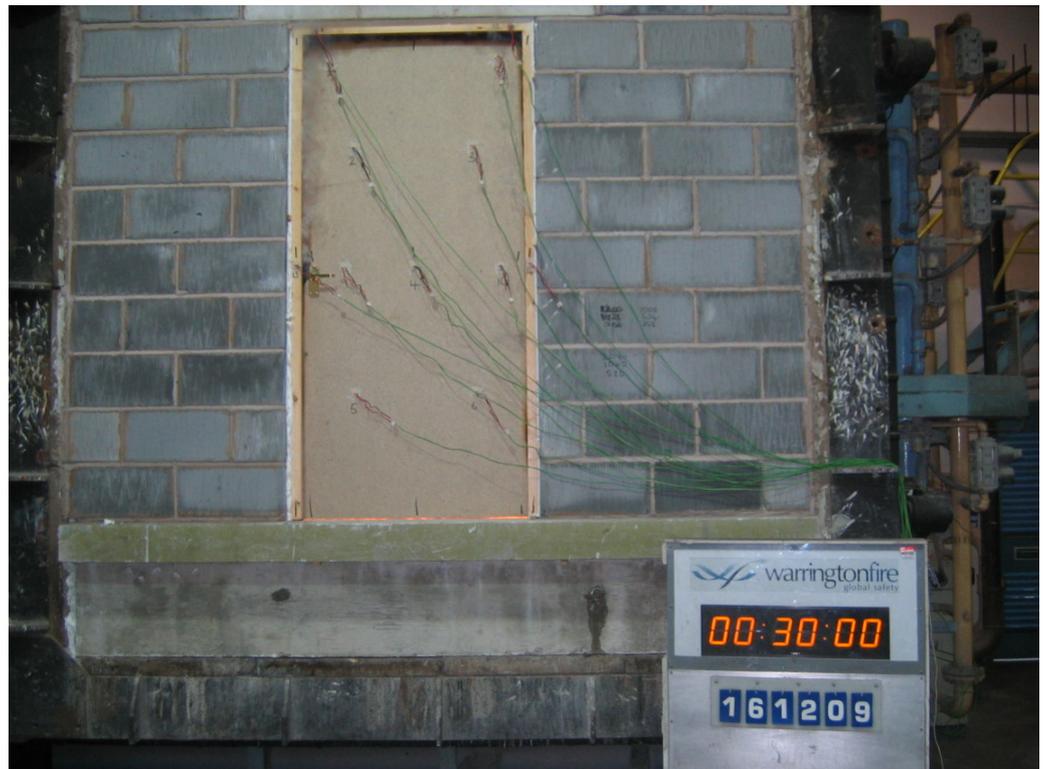
The unexposed face of the doorset after 30 minutes of testing

mins	secs	
30	00	The specimen continues to satisfy all integrity and insulation criteria.
30	30	Smoke issue is increasing at the head of the specimen.
32	00	All gaps between the leaf and stop on both vertical edges continue to increase. Leading edge approximately 30 mm, hinged edge approximately 15 mm.
34	00	The area of door leaf between the handle and the door frame is blackening.
36	00	A small area of glowing is becoming visible at the latch position.
37	00	The leading edge of the threshold is starting to burn through approximately 30 mm up from threshold.
38	00	Glowing is visible at the bottom hinge position.
40	50	Flickering flames at latch position and bottom hinge.
41	10	Sustained flaming at latch and lower hinge position sustained flaming. Sustained flaming Integrity failure is deemed to have occurred.
41	40	Sustained flaming at the head.
42	00	The test is discontinued.

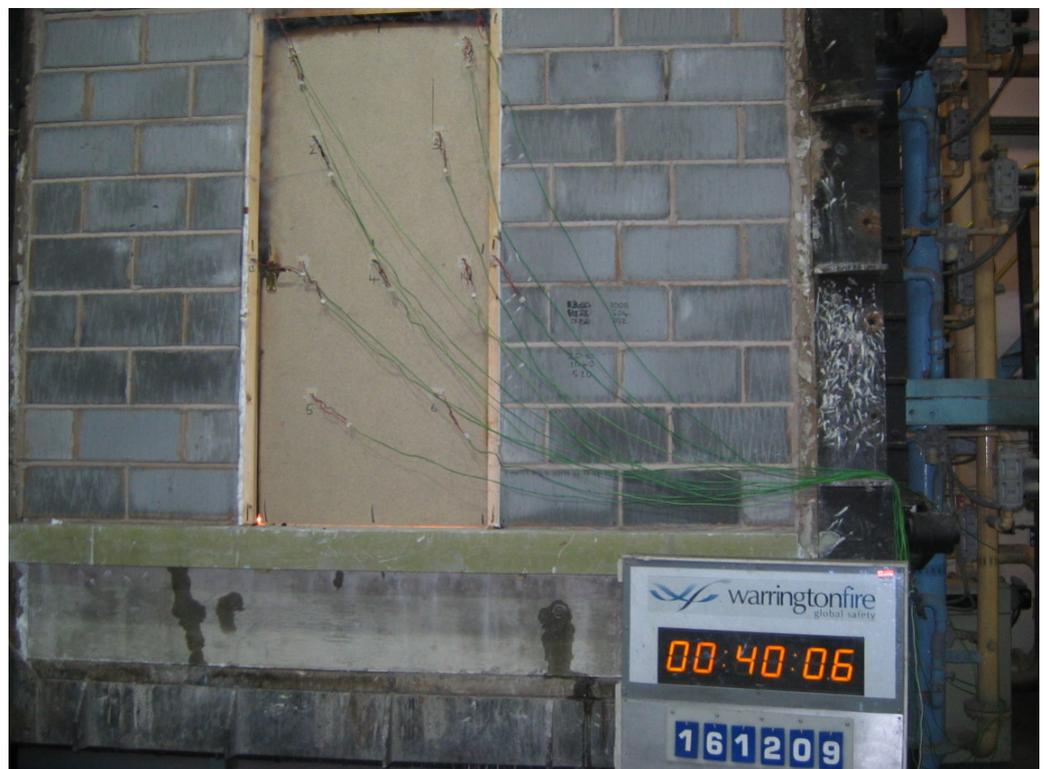
The unexposed face of the doorset after 40 minutes of testing

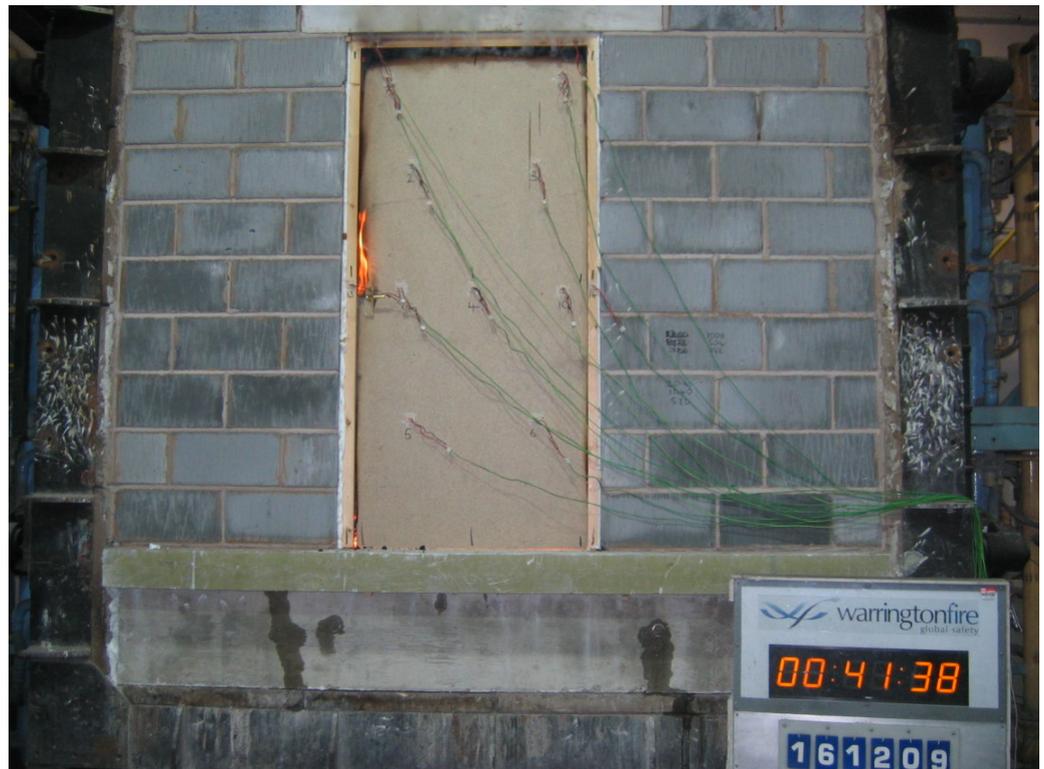
**Sustained
flaming integrity
failure of the
doorset after a
duration of 41
minutes**

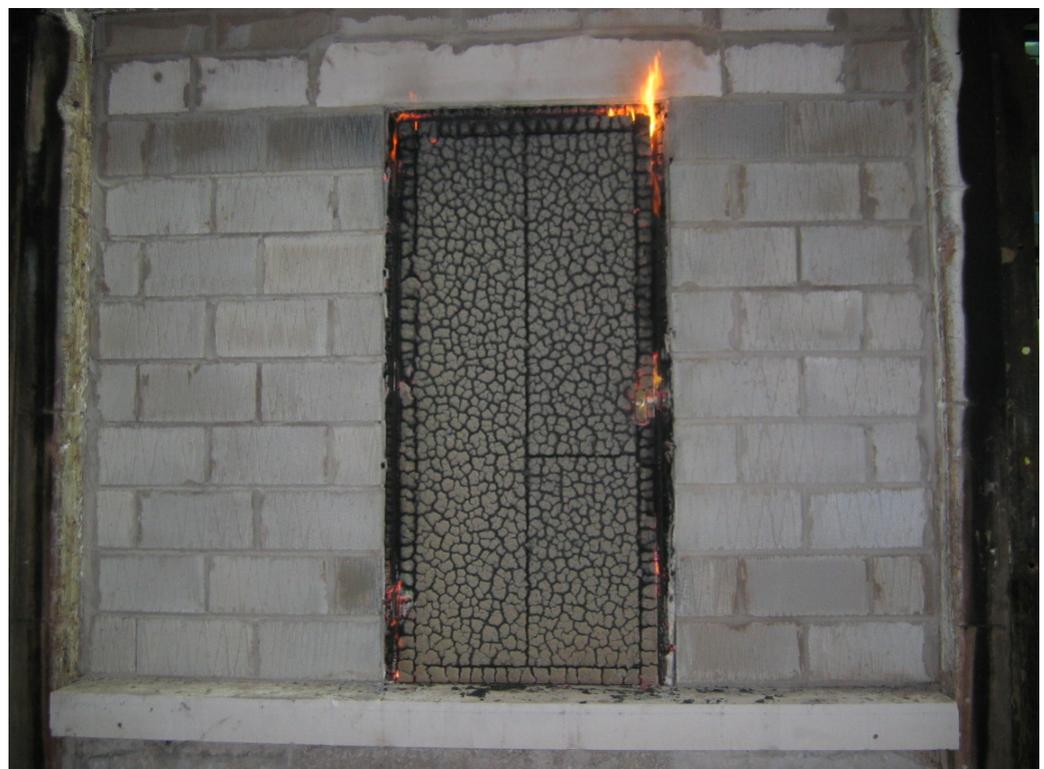
**The exposed
face of the
doorset
immediately
after the test**

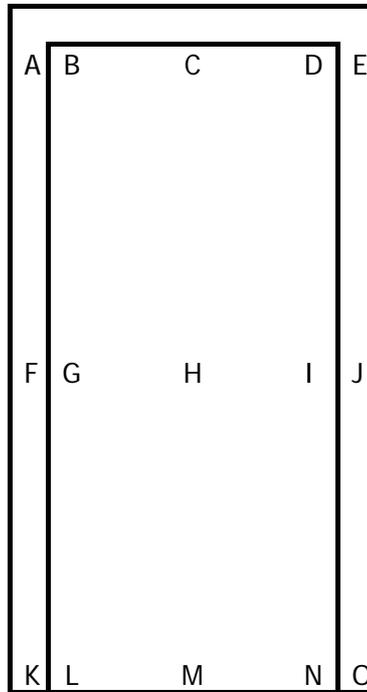
Deflections of the Door Leaf and Frame During the Test

Deflections - mm															
TIME mins	A	B	C	D	E	F	G	H	I	J	K	L	M	N	O
0	0	0	0	0	0	0	0	0	0	0	0	0	0	0	0
5	6	3	1	1	0	-1	-1	-2	-1	0	1	0	1	2	1
10	3	6	4	3	2	-1	-1	-4	-2	-1	0	3	2	2	1
15	1	11	3	6	1	-1	-1	-4	-3	-1	1	4	4	4	5
20	4	13	5	7	1	-1	-1	-5	-2	-1	2	7	7	6	8
25	3	13	4	10	2	-1	-1	-7	-2	-1	2	14	10	12	1
30	4	15	5	12	2	-1	-1	-8	-3	0	1	-3	11	14	1

Negative values indicate movement away from the furnace

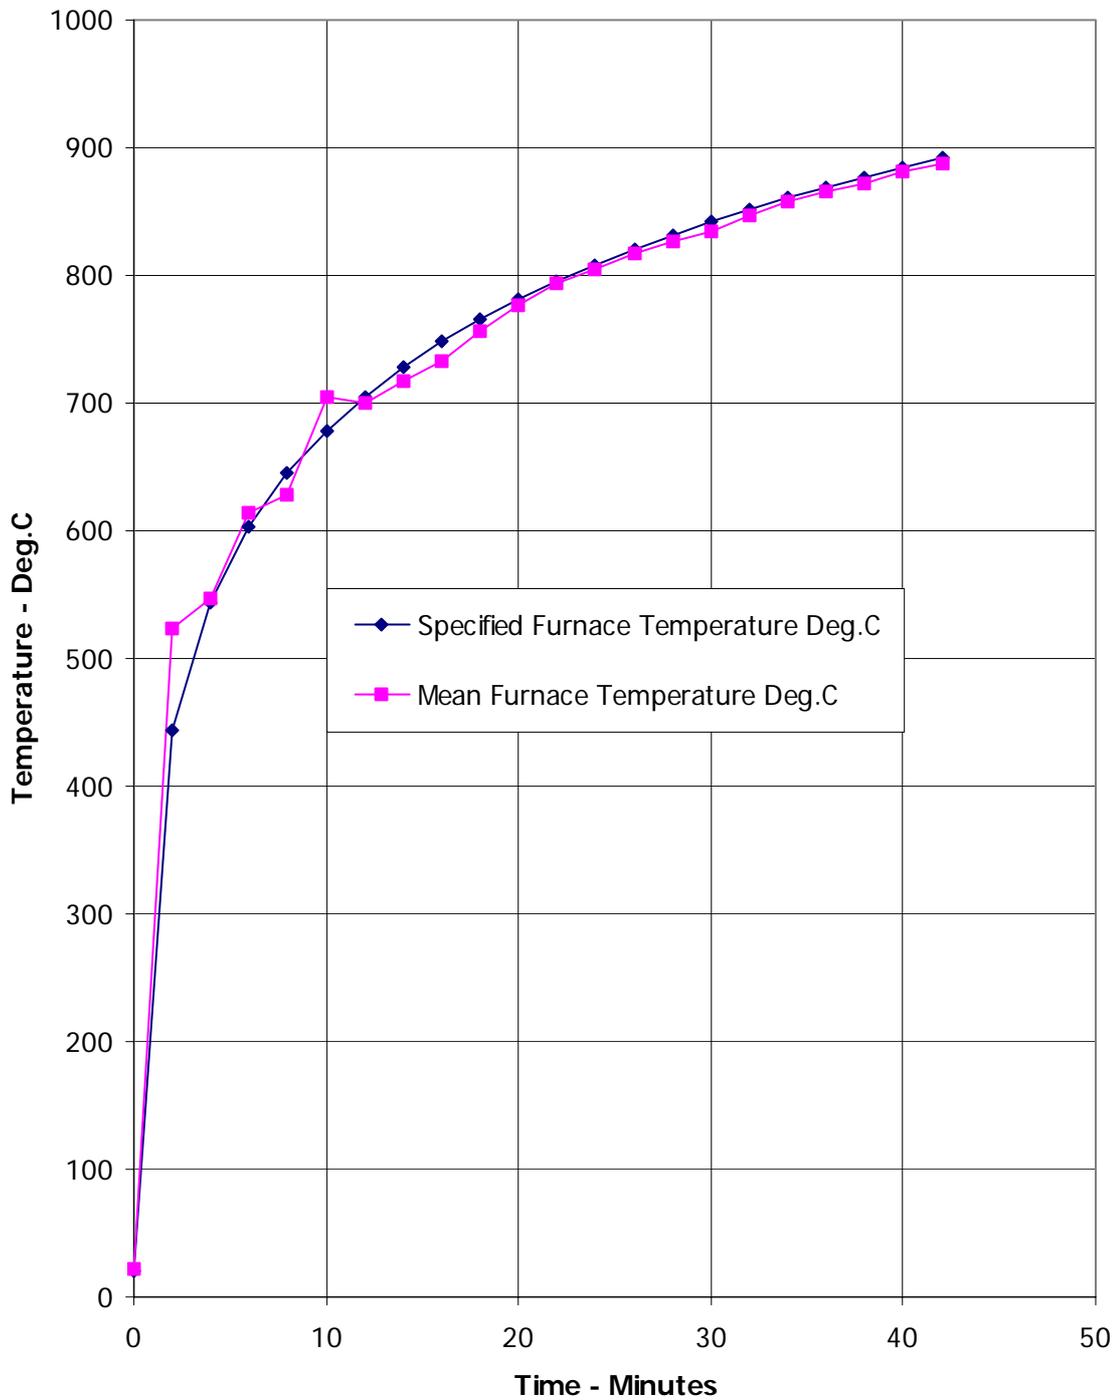
Graph showing mean furnace temperature, together with the temperature/time relationship specified in the Standard

Time Minutes	Specified Furnace Temperature Deg. C	Mean Furnace Temperature Deg. C
0	20	21
2	445	523
4	544	546
6	603	615
8	645	628
10	678	704
12	705	701
14	728	717
16	748	732
18	766	757
20	781	777
22	796	794
24	809	805
26	820	816
28	832	826
30	842	835
32	851	847
34	860	858
36	869	865
38	877	873
40	885	881
42	892	887

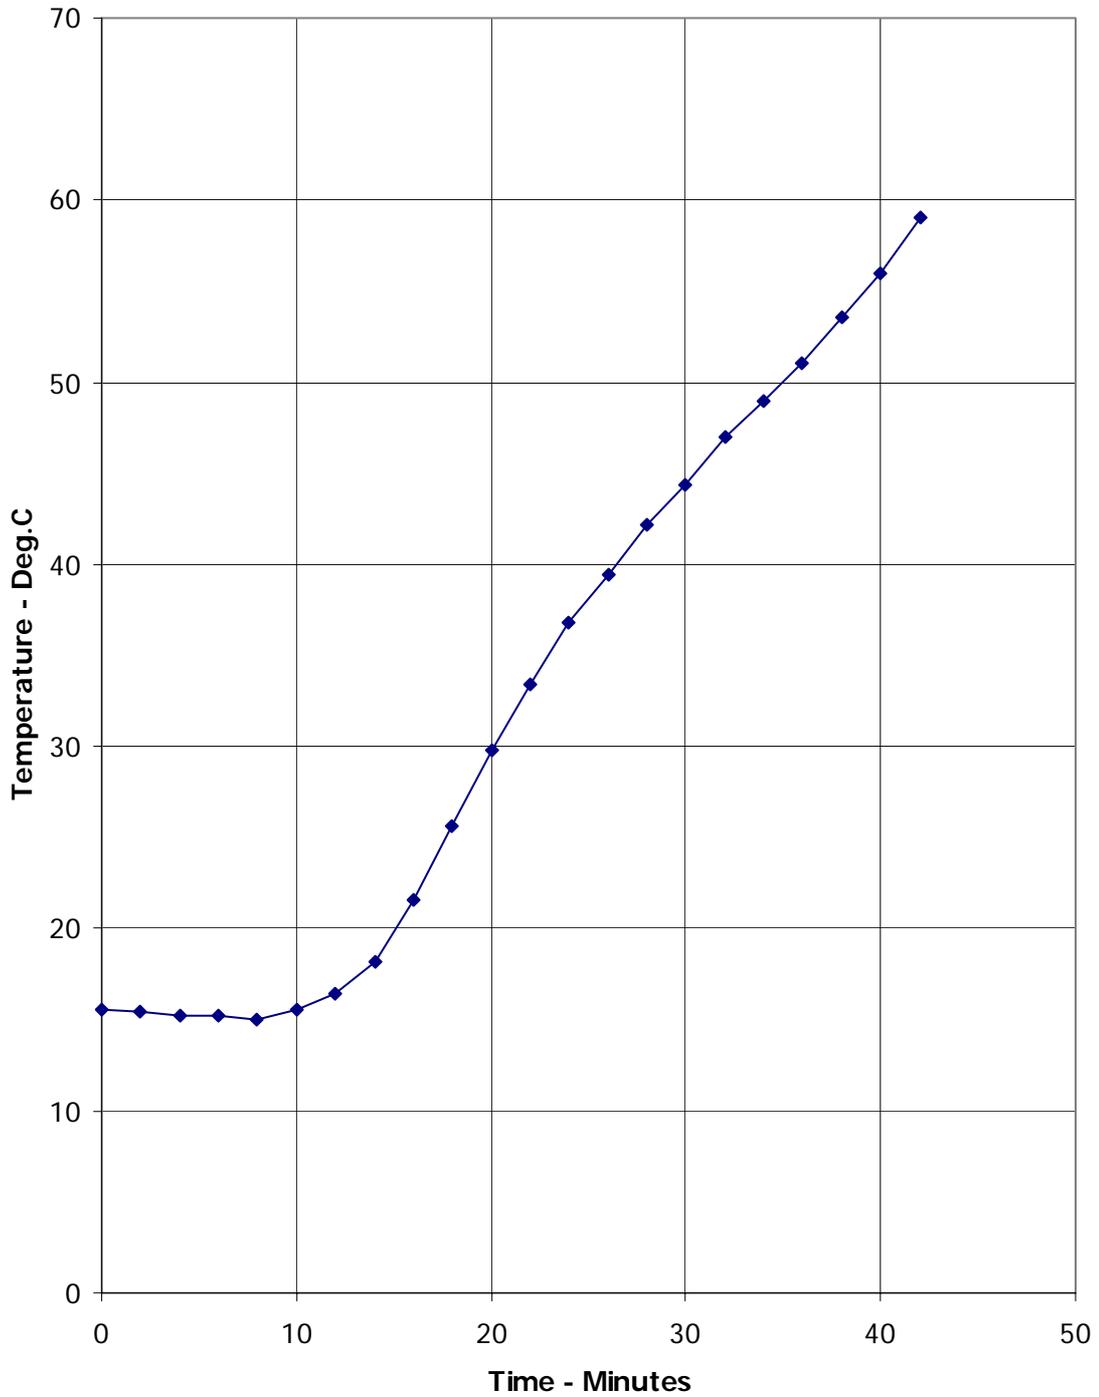
Graph showing mean temperatures recorded on the unexposed surface of the doorset

Time Minutes	T/C Number 2 Deg. C	T/C Number 3 Deg. C	T/C Number 4 Deg. C	T/C Number 5 Deg. C	T/C Number 6 Deg. C	Mean Temperature Deg. C
0	15	16	16	16	15	16
2	15	16	16	15	15	15
4	15	16	15	15	15	15
6	15	16	15	15	15	15
8	15	15	15	15	15	15
10	15	16	16	16	15	16
12	16	16	17	17	16	16
14	19	17	18	20	17	18
16	23	20	21	25	19	22
18	28	23	25	29	23	26
20	32	27	29	34	27	30
22	35	31	33	37	31	33
24	39	34	36	40	35	37
26	41	37	39	43	37	39
28	44	40	42	45	40	42
30	46	42	44	47	43	44
32	49	44	47	50	45	47
34	51	46	49	52	47	49
36	53	48	51	54	49	51
38	55	50	54	57	52	54
40	58	52	57	59	54	56
42	62	54	61	62	56	59

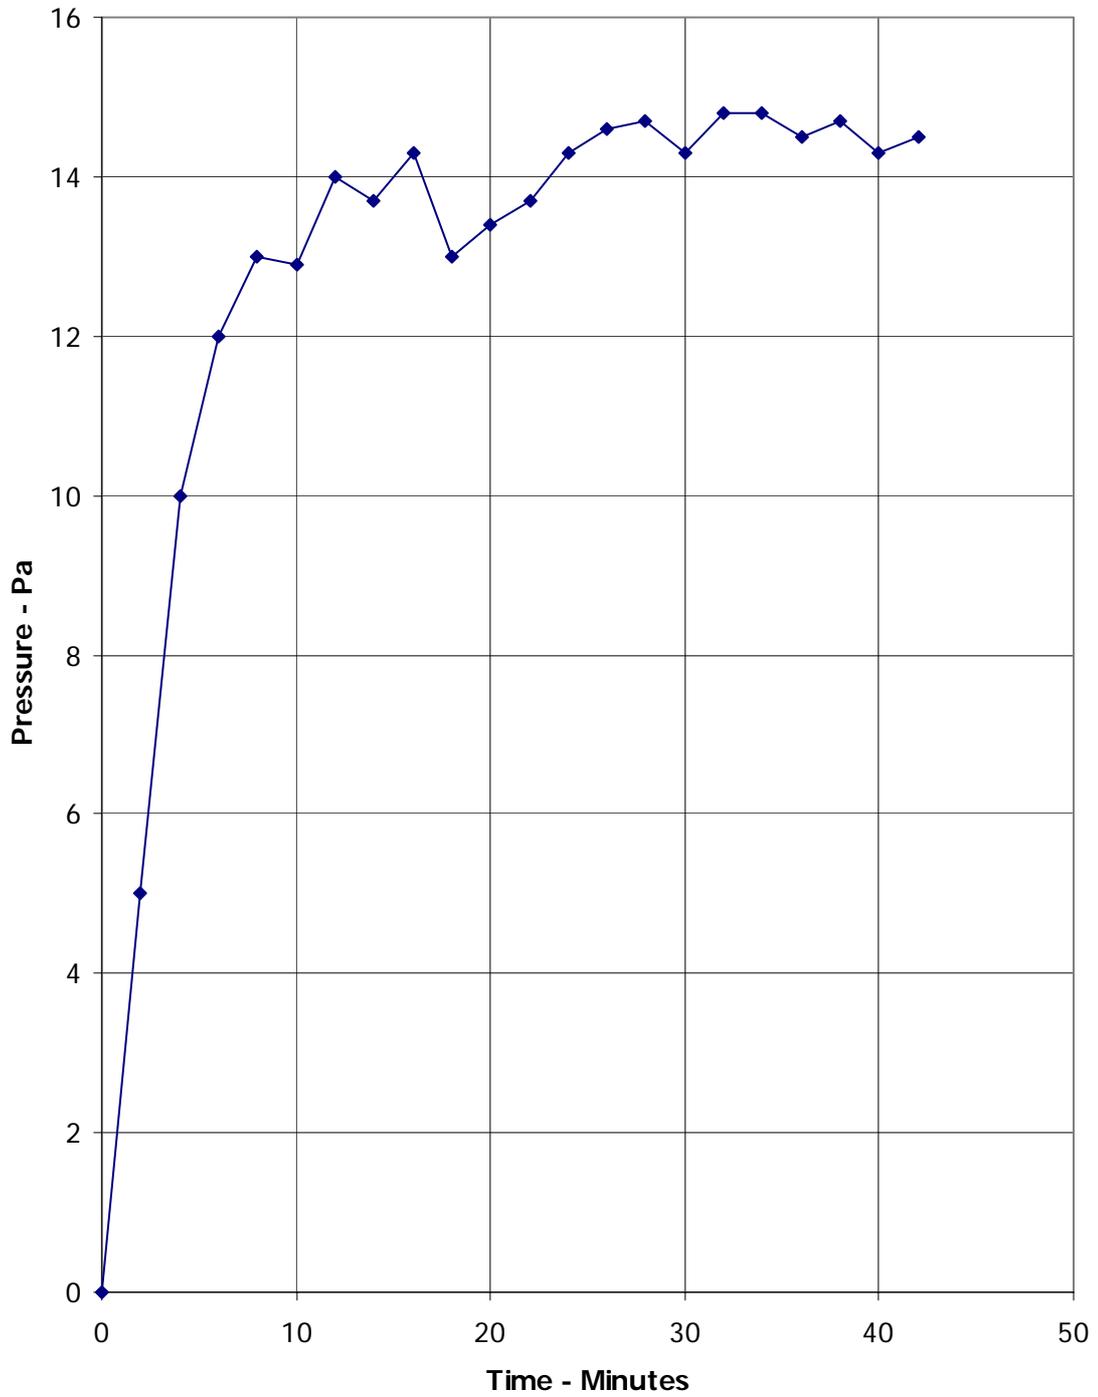
Graph showing recorded furnace pressure at the head of the doorset

Roving Thermocouple	A roving thermocouple was available to measure temperatures on the unexposed surface of the specimens at any position which might appear to be hotter than the temperatures indicated by the fixed thermocouples.
Integrity Criteria	Cotton pads and gap gauges were available to evaluate the integrity of the specimen.
Furnace Pressure	The furnace atmospheric pressure was controlled so that it complied with the requirements of BS EN 1363-1: 1999. Clause 5.2. The calculated pressure differential relative to the laboratory atmosphere at the top of the doorset was 13.4 (± 3) Pa.
